CASITAS MUNICIPAL WATER DISTRICT RINCON PUMP PLANT ELECTRICAL UPGRADE SPECIFICATION NO. 17-397

ADDENDUM NO.2

Subject: Limited Pre-Removal Lead in Paint and Asbestos Survey

Site: Rincon Pump Station, Casitas Vista Road, Ventura, CA

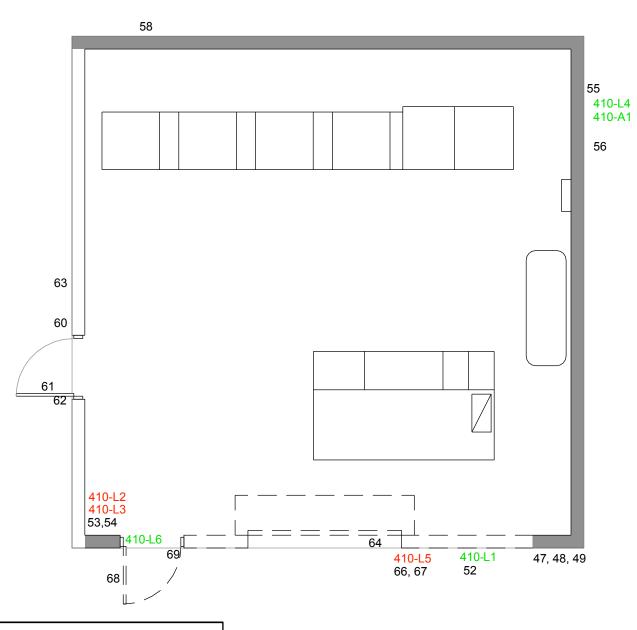
Lead and Asbestos Sampling Locations
Rincon Pump House
Casitas Vista Road, Ventura, CA

Sample No	Component	Room	Color	Lead Content (ppm)
410-L1	Block Wall	Exterior	White	ND
410-L2	Steel Beam	Interior	Gray	29,000
410-L3	Ceiling	Interior	Gray	24,000
410-L4	Window Frame	Exterior	White	ND
410-L5	Roll-up Door Frame	Exterior	White/Gray	19,000
410-L6	South Door Frame	Exterior	White	ND

Lead exceeding 600 ppm was present on the roll-up door frame and on the interior ceiling and metal support structure. Any work which disturbs the paint in these areas is considered lead-related work. Removal of lead-based paint or lead-containing paint is not required prior to demolition or renovation. The demolition contractor must comply with the requirements of the Cal/OSHA Lead in Construction Standard (8CCR§1532.1) regarding protection of employees from exposure to lead.

Torch cutting or welding of materials coated with paint exceeding 600ppm should be prohibited on this project. Wherever possible it is recommended that building components coated with lead containing paint be removed intact.
