2006 Annual Progress Report
of the
Robles Diversion Fish Passage Facility

Casitas Municipal Water District
1055 Ventura Avenue
Oak View, California 93022

November 2006

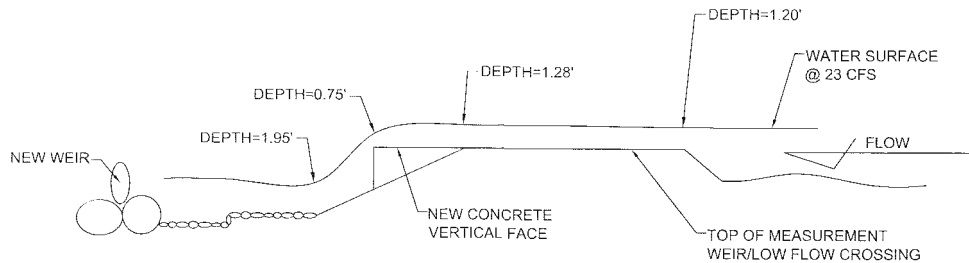
CROSS SECTION
MEASUREMENT WEIR/LOW FLOW
CROSSING AT 23 CFS

The January 2, 2006 storm flows caused the top row of rocks on the two upstream weirs to roll forward, reducing their effective height. The reduced height resulted in a jump remaining at the weir at 20 cfs flows. The weir design intended for the downstream pool to be at the edge of the measurement weir/low flow crossing (MWLF) at 20 cfs flows. At 23 cfs flows, the following dimensions were taken using a hand held survey rod:

Depth of downstream pool at the face of the MWLF	1.95 feet
Bottom of downstream pool to water surface on the MLWF	4.56 feet
Depth of water at the downstream edge of the MWLF	0.75 feet
Depth of water in the middle of the MWLF	1.28 feet
Depth of water at the upstream edge of the MWLF	1.20 feet

The current jump and pool depth are an improvement over the previous conditions where the vertical jump was 3.8 feet, the horizontal jump was about 8 feet and the pool depth was 0.1-0.3 feet. Provided surface flow stops on the stream at the weirs, repairs will be made to the weirs during the summer/fall of 2006, further reducing the jump required.

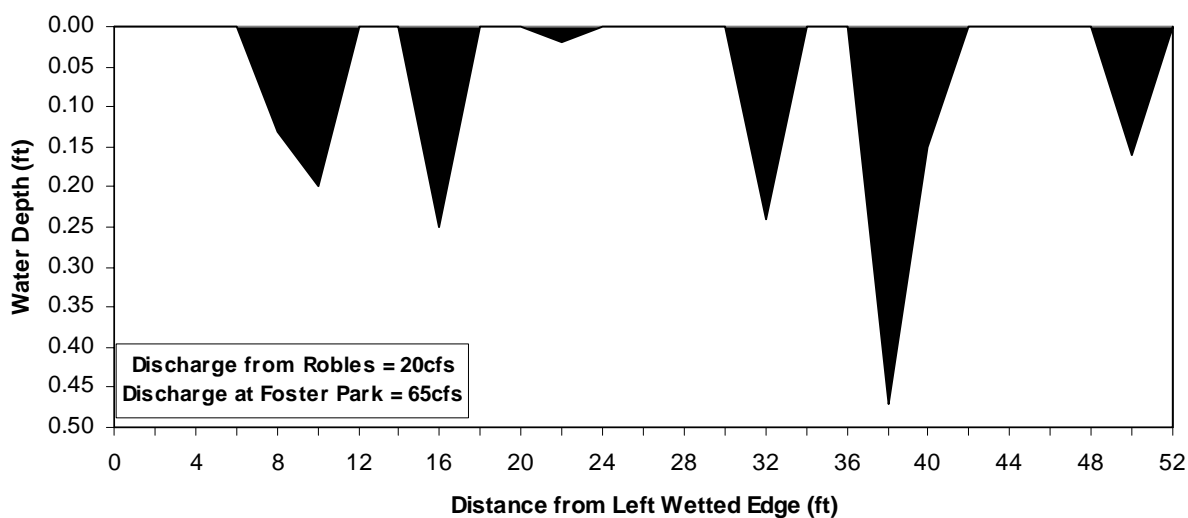
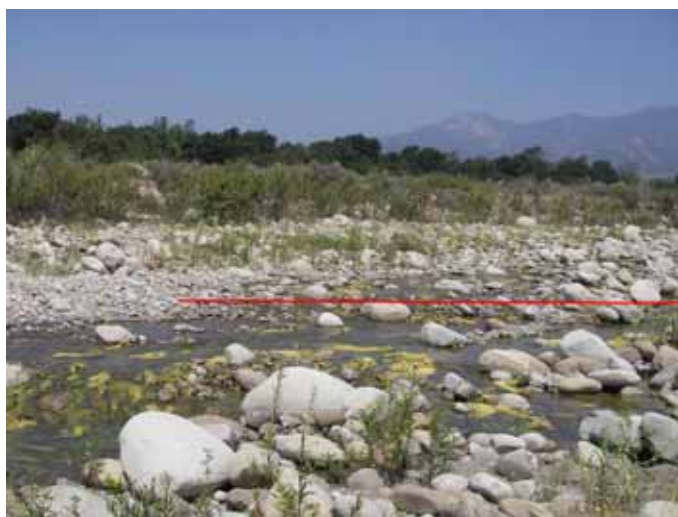
Appendix 1.1. Table, graph, and photo of transect 1.

Distance (ft)	Depth (ft)	Distance (ft)	Depth (ft)	Distance (ft)	Depth (ft)
0	0	18	0	36	0
2	0	20	0	38	0.47
4	0	22	0.02	40	0.15
6	0	24	0	42	0
8	0.13	26	0	44	0
10	0.2	28	0	46	0
12	0	30	0	48	0
14	0	32	0.24	50	0.16
16	0.25	34	0	52	0

Transect 1 (site 4 in Entrix 1999) was located just upstream of the HWY 150 bridge at approximately RM 11.5 and was about 2.5 miles downstream of the Robles Facility. The transect had a total of 28 depths measured across the wetted channel. Of those, only eight had a depth of water to measure, and the remaining were exposed. The depths of water measured ranged from 0.02 ft to 0.47 ft and represented approximately 30% of the measurements. The mean for the measured depths was 0.20 ft. The mean depth for the entire transect that included exposed areas was 0.06 ft. The Discharge of the Ventura River just downstream of the Robles Facility at the time of the survey was measured at 20 cfs and the discharge at the USGS gage near Foster Park was 65 cfs (Appendix 1.1).

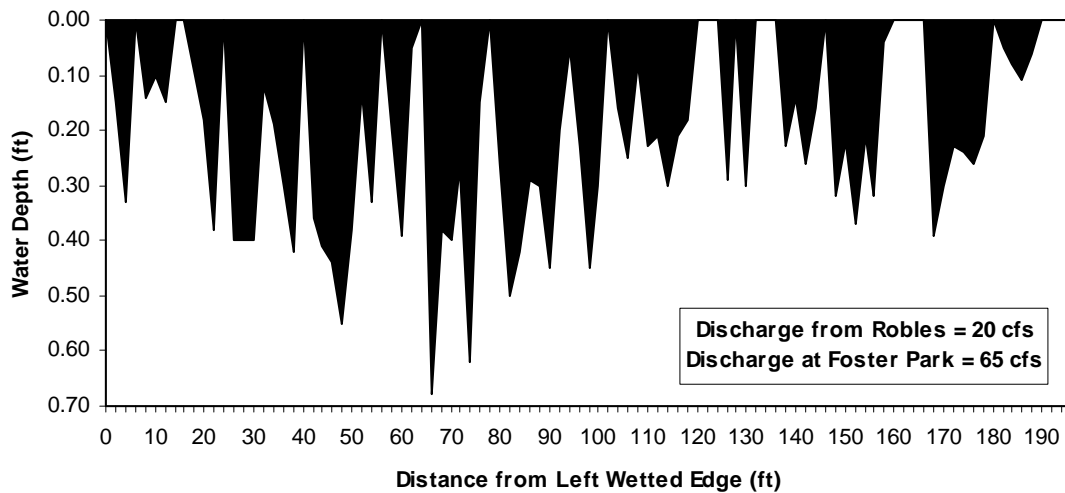
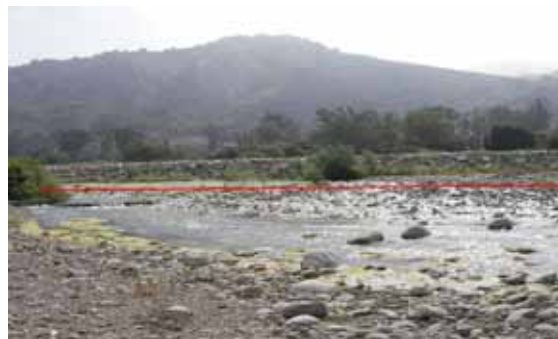
Appendix 1.2. Table, graph, and photo of transect 2.

Distance (ft)	Depth (ft)	Distance (ft)	Depth (ft)	Distance (ft)	Depth (ft)	Distance (ft)	Depth (ft)	Distance (ft)	Depth (ft)
0	0	40	0	80	0.26	120	0	160	0
2	0.15	42	0.36	82	0.5	122	0	162	0
4	0.33	44	0.41	84	0.42	124	0	164	0
6	0	46	0.44	86	0.29	126	0.29	166	0
8	0.14	48	0.55	88	0.3	128	0	168	0.39
10	0.1	50	0.38	90	0.45	130	0.3	170	0.3
12	0.15	52	0.13	92	0.2	132	0	172	0.23
14	0	54	0.33	94	0.05	134	0	174	0.24
16	0	56	0	96	0.23	136	0	176	0.26
18	0.09	58	0.2	98	0.45	138	0.23	178	0.21
20	0.18	60	0.39	100	0.3	140	0.14	180	0
22	0.38	62	0.05	102	0	142	0.26	182	0.05
24	0	64	0	104	0.16	144	0.16	184	0.08
26	0.4	66	0.68	106	0.25	146	0	186	0.11
28	0.4	68	0.38	108	0.08	148	0.32	188	0.06
30	0.4	70	0.4	110	0.23	150	0.22	190	0
32	0.12	72	0.27	112	0.21	152	0.37	192	0
34	0.19	74	0.62	114	0.3	154	0.21	194	0
36	0.3	76	0.15	116	0.21	156	0.32	196	0
38	0.42	78	0	118	0.18	158	0.04

Transect 2 (site 7 in Entrix 1999) was located just downstream of the Arroyo Mobile Home Park at approximately RM 7.5 and was about 6.5 miles down stream of the Robles Facility. The transect had a total of 99 depths measured across the wetted channel. Of those, 72 were able to have a depth measured and the remainder were dry. The depths ranged from 0.04 ft to 0.68 ft. The mean depth of the measured depths was 0.27 ft and the mean depth of the entire transect that included the exposed areas was 0.20. Discharge past the Robles Facility at the time of the survey was measured at 20 cfs and the discharge at the USGS gage near Foster Park was 65 cfs (Appendix 1.2).

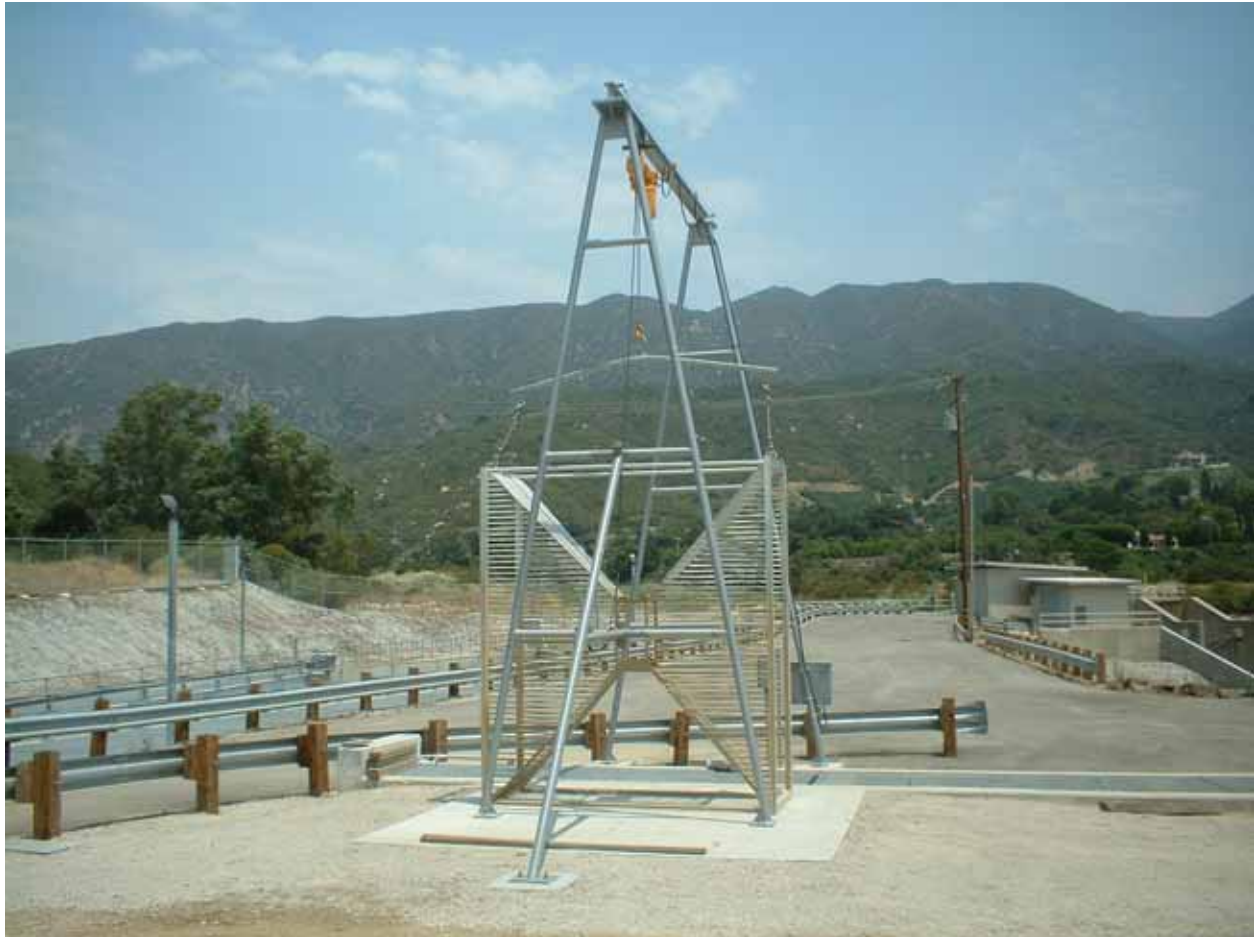
Appendix 4. Photo of the fish crowder that directs migrants through the Vaki Riverwatcher scanner. The crowder is out of fish bypass and not operational in photo. Also in photo is the A-frame hoist that was completed in 2006 that will allow for easy removal of the crowder for cleaning and repair.

Fish passage monitoring within the Robles Facility was accomplished using a Vaki Riverwatcher (Riverwatcher). The Riverwatcher consists of a scanner with light diodes that send infrared light beams to receivers on the other side. When a fish swims through the infrared beams of light, it breaks the signal and a silhouette is recorded on a computer. Also when a fish swims through the infrared light beams, the scanner triggers an underwater camera to record a short video clip. Only fish swimming upstream can be recorded because the camera is on the upstream side of the scanner. Other data recorded when the scanner is triggered are: date and time, length of the fish (from a length/height ratio), swimming speed (m/sec), and direction of the fish movement (upstream or downstream). The scanner is positioned in the center of an aluminum frame covered with 1/2 inch aluminum bars, spaced apart 2 inches on center, with a resulting 1 1/2 inch spacing between the bars that crowds the fish and directs them to swim through the scanner (Appendix 4). This crowder acts essentially as a bottleneck for the fish to swim through so they can be counted in both an up- and

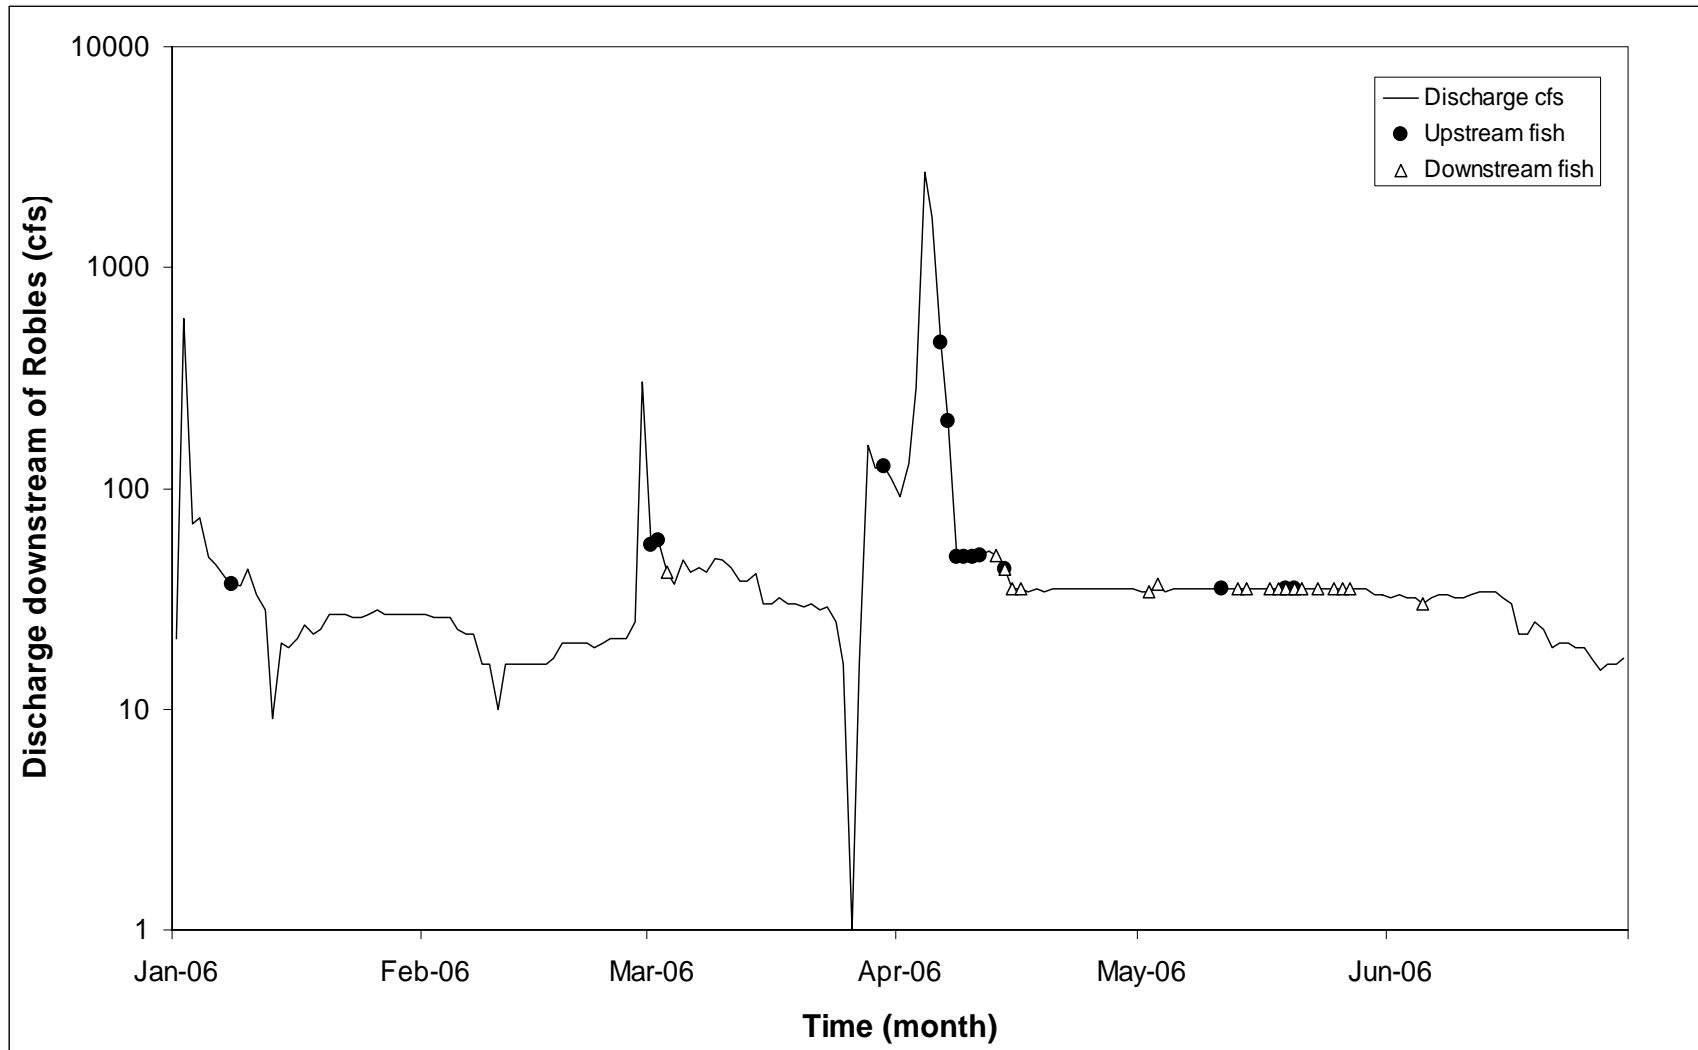
Appendix 6. Discharge downstream of Robles Fish Passage Facility in relation to upstream and downstream migrating fish that passed through the Vaki Riverwatcher during 2006.

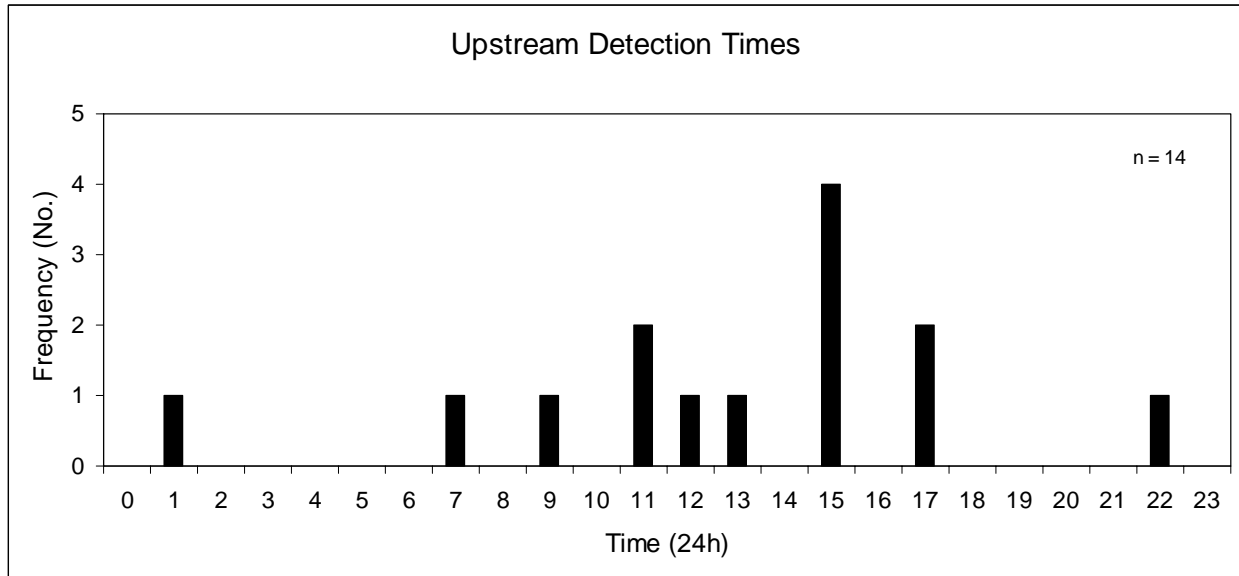
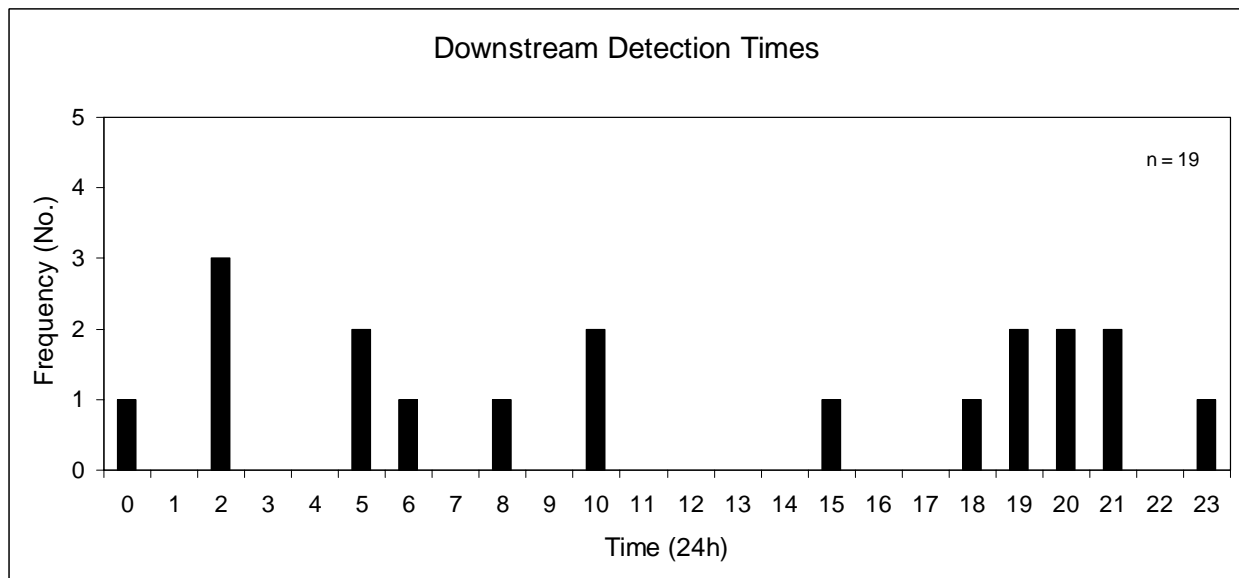
Appendix 7. Upstream and downstream frequency distributions of detection times.

The dates of the upstream detections for *O. mykiss* and other probable fish ranged from January 8th to May 5th and the mean date for upstream fish detected at the Riverwatcher was April 4th. The dates of the 19 downstream detections, which were determined to be probable fish, ranged from March 3rd to June 6th the day before the Riverwatcher was removed for the season. The mean date of downstream detections was May 7th. The dates of the upstream migrating fish seem to be primarily associated with the receding limb of the four runoff events in the Ventura River (Appendix 6). The diel migration pattern was different for the two directions. The median time for upstream detections through the Riverwatcher was approximately 1400 h, whereas the downstream median time was approximately 0100 h (Appendix 7).

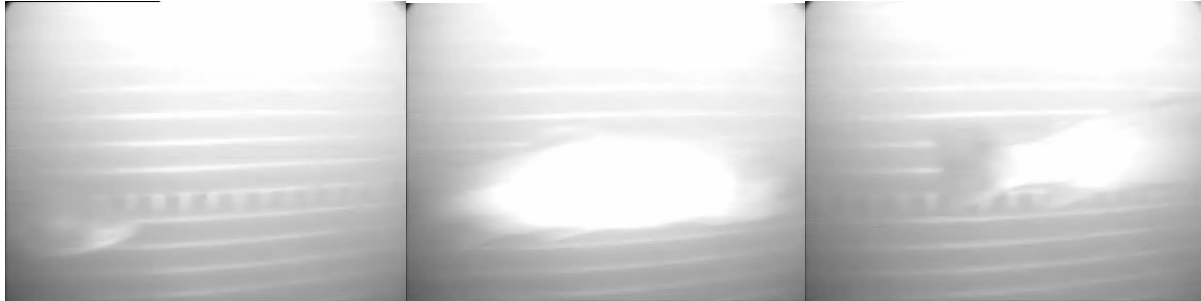
Series 1. *O. mykiss* recorded on 04-08-06 at 15:27 h and was estimated to be 25 cm.

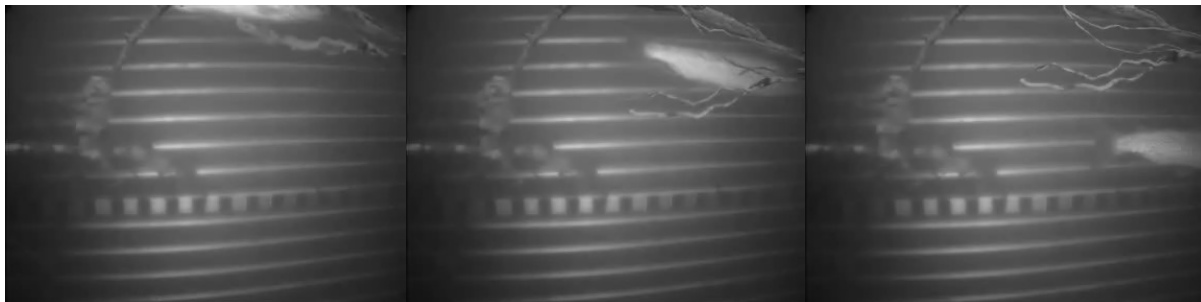
Series 2. *O. mykiss* detected on 04-10-06 at 07:02 h and was estimated to be 34 cm.

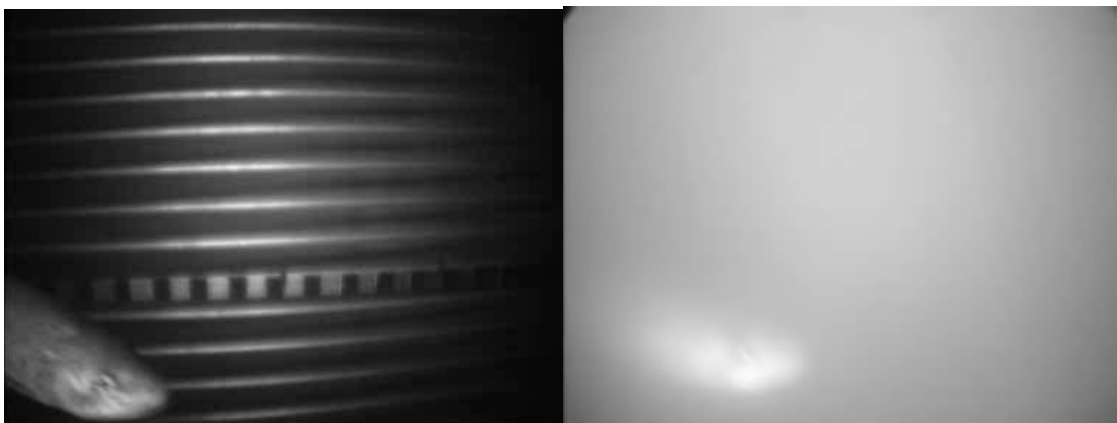
Photo 1. *O. mykiss* detected on 04-14-06 at 01:23 h and was estimated to be 31 cm.

Photo 2. Example of turbidity obscuring the identification of a fish .

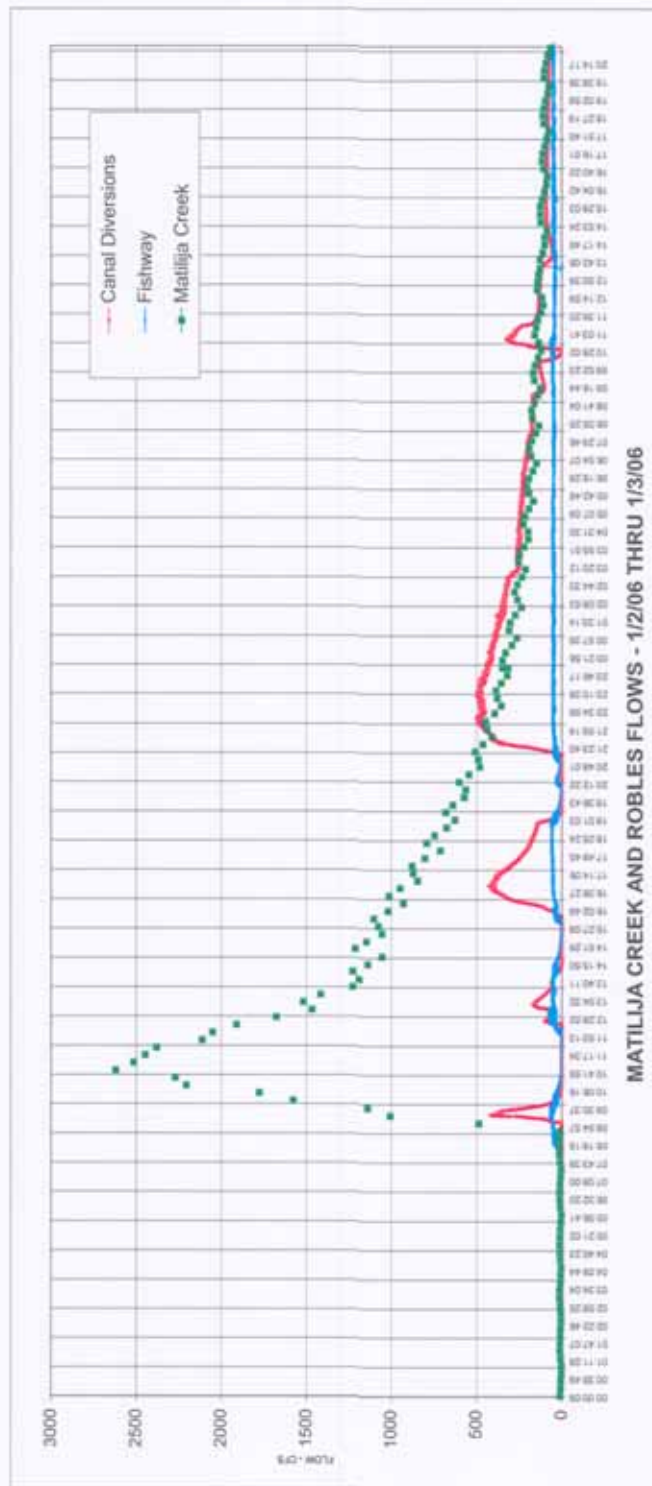
Figure 1 - Storm Event of January 2 thru 3, 2006

(Note that North Fork flow conditions are not included for total inflow into Robles)

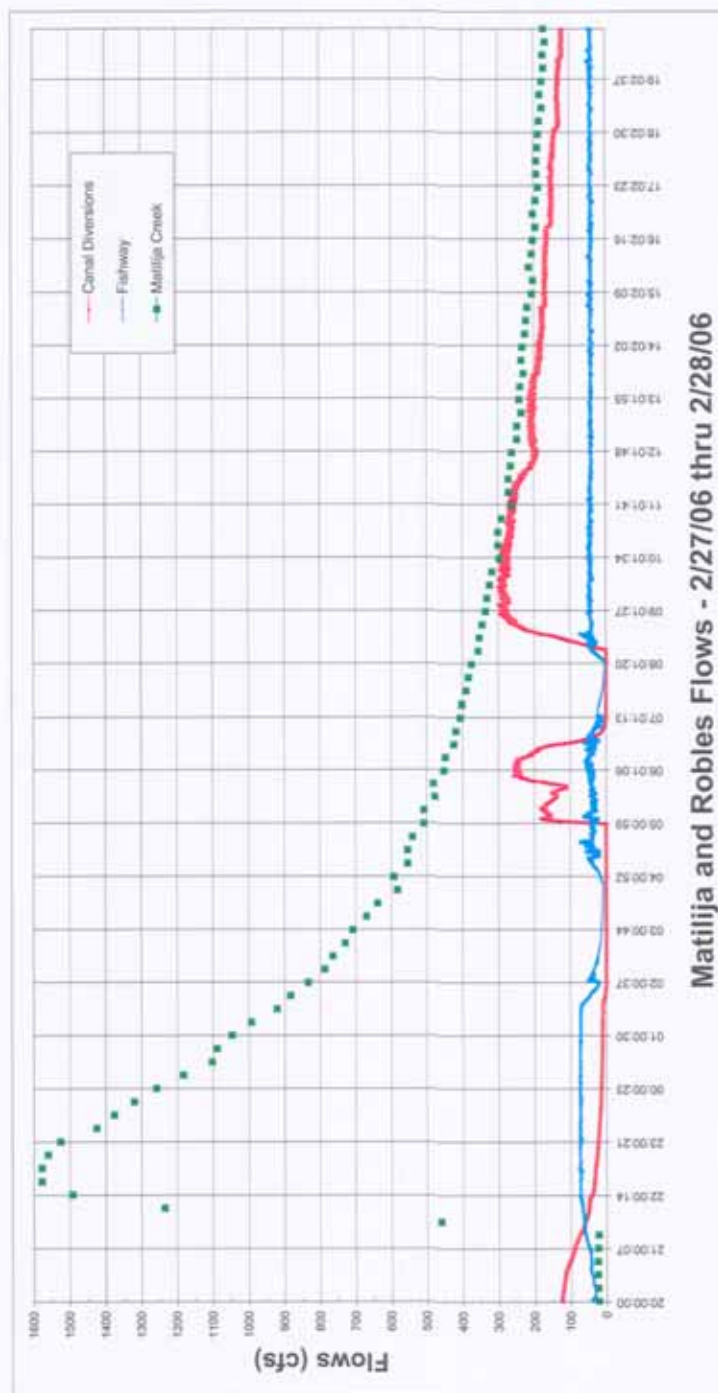
Figure 2 - Storm Event of February 27 thru 28, 2006

(Note that North Fork flow conditions are not included for total inflow into Robles.)

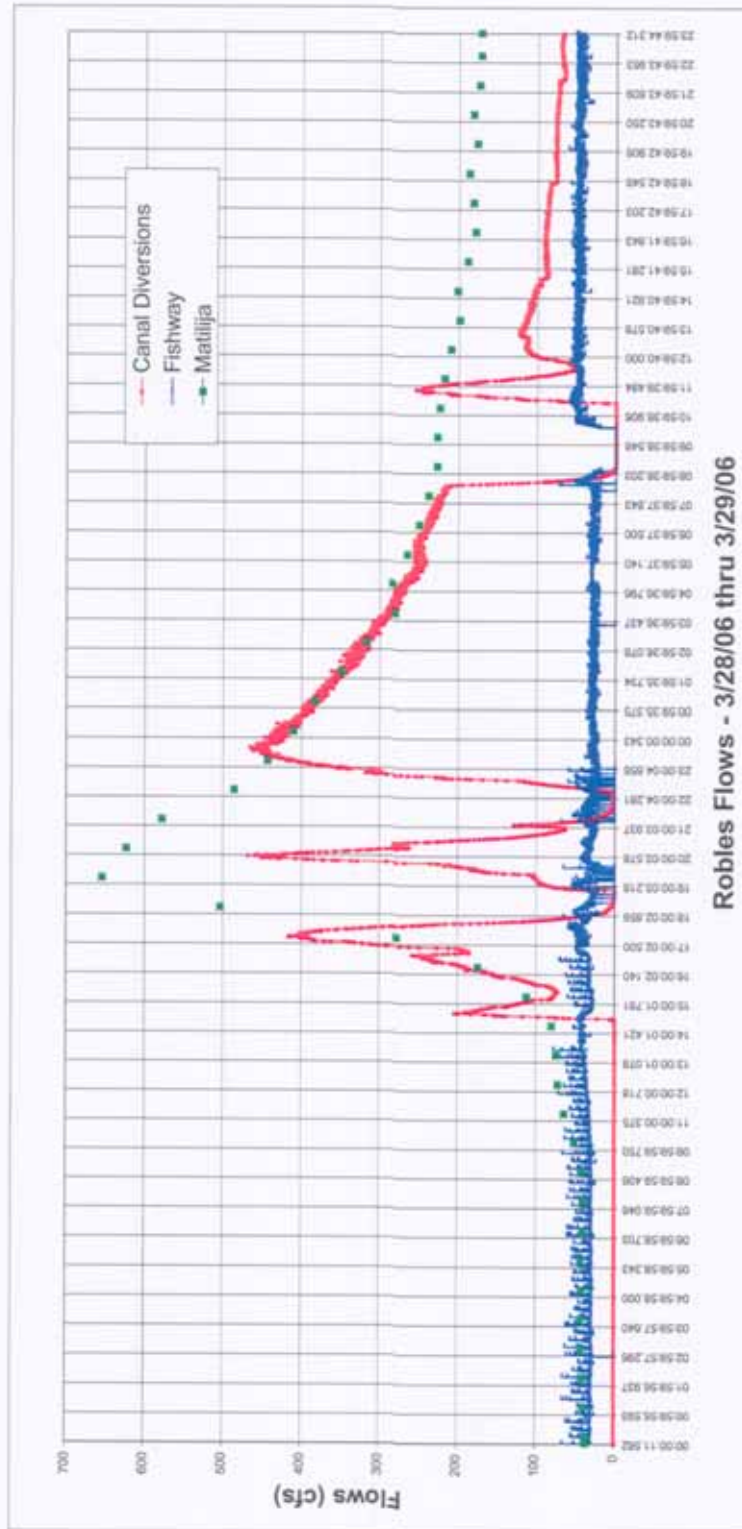
Figure 3 - Storm Event of March 28 thru 29, 2006

(Note that North Fork flow conditions are not included for total inflow into Robles.)
