Biological Resources Assessment

January 28, 2019  
Project No: 18-06232

**Subject: Casitas Municipal Water District Ojai Water System Improvements Project Biological Resources Assessment**

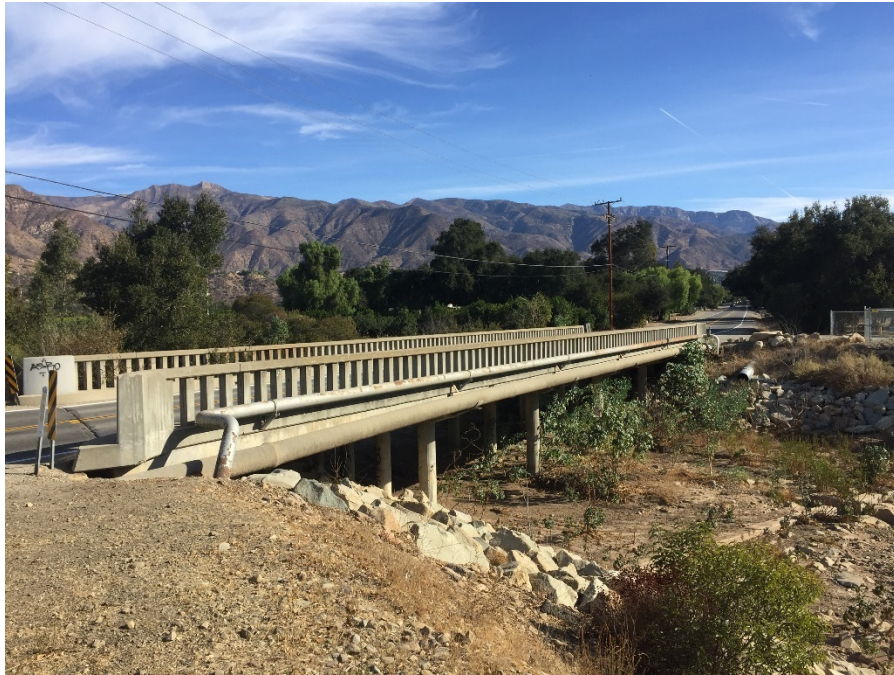
**Photograph 1.** View of existing pipeline alignment within BSA, facing northeast (Unit A). Photograph shows suspended pipe above San Antonio Creek adjacent to Grand Avenue Bridge. November 13, 2018.

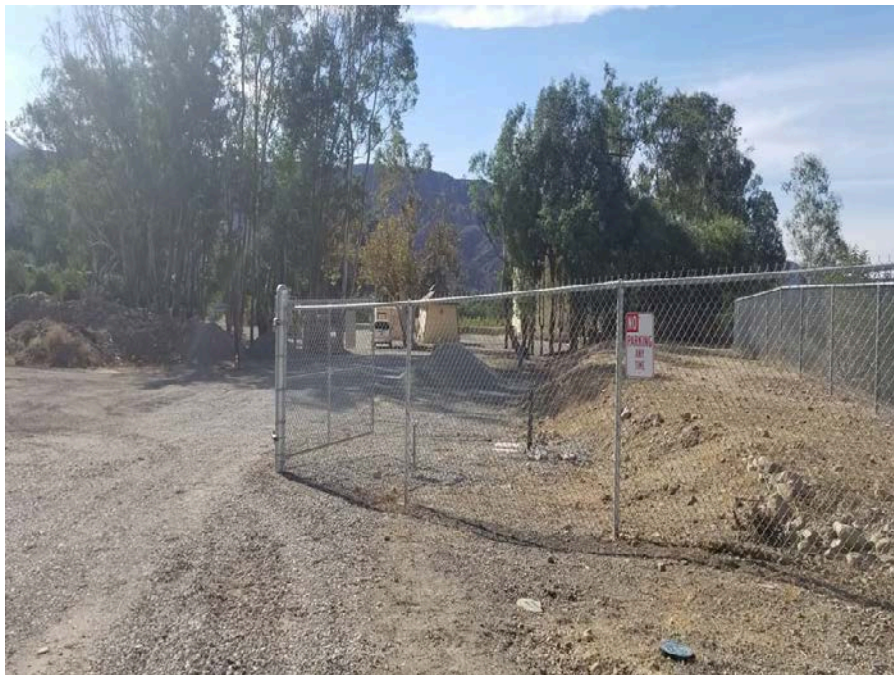
**Photograph 2.** View of existing wells, tanks, and pumps infrastructure within BSA, east of San Antonio Creek, facing south (Unit A). Note eucalyptus trees within BSA. November 13, 2018.

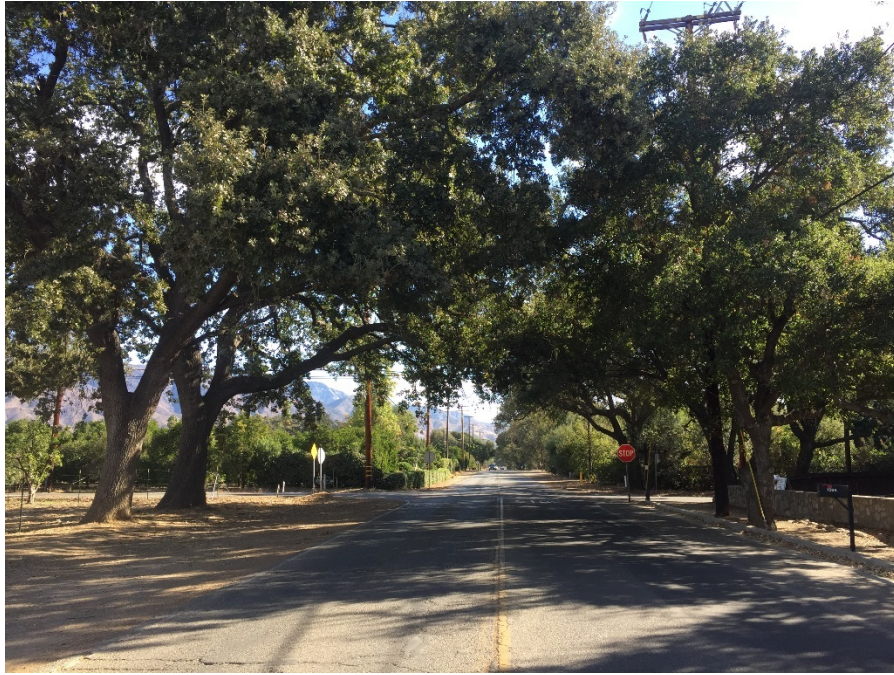
**Photograph 3.** View of existing pipeline alignment within BSA, facing west (Unit A). Note remnant valley oak trees above the project footprint. November 13, 2018.

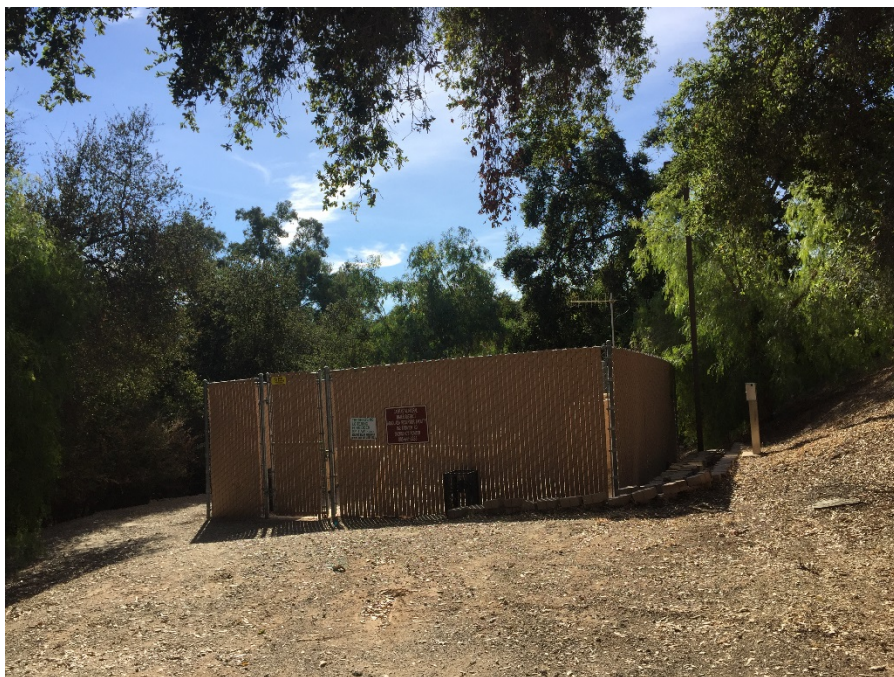
**Photograph 4.** View of existing Fairview Pump station within BSA, facing south (Unit B). November 13, 2018.

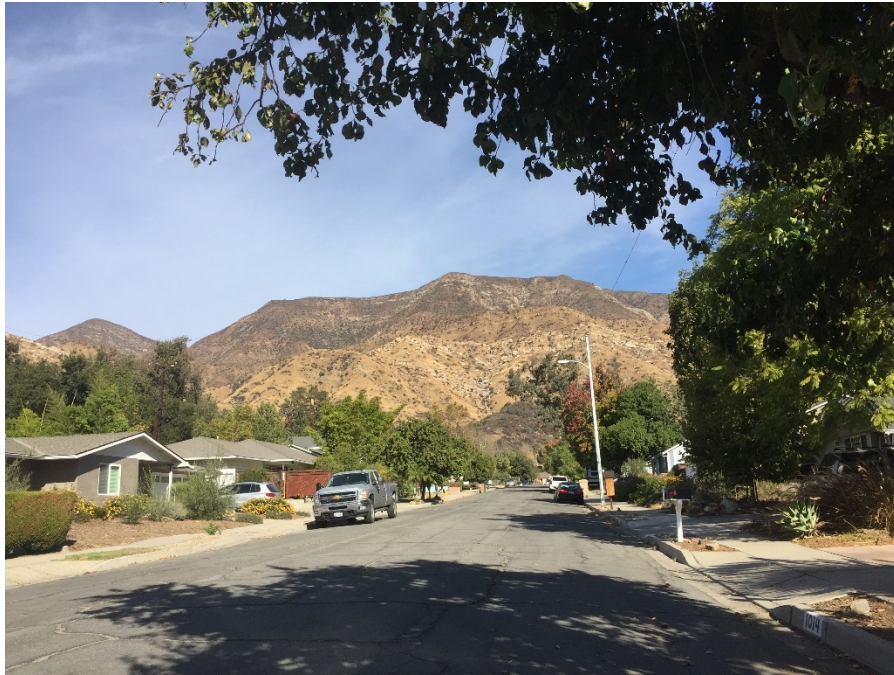
**Photograph 5.** View North Sunset Place of existing pipeline alignment within BSA, facing north (Unit B). Note ornamental vegetation surrounding the project footprint. November 13, 2018.

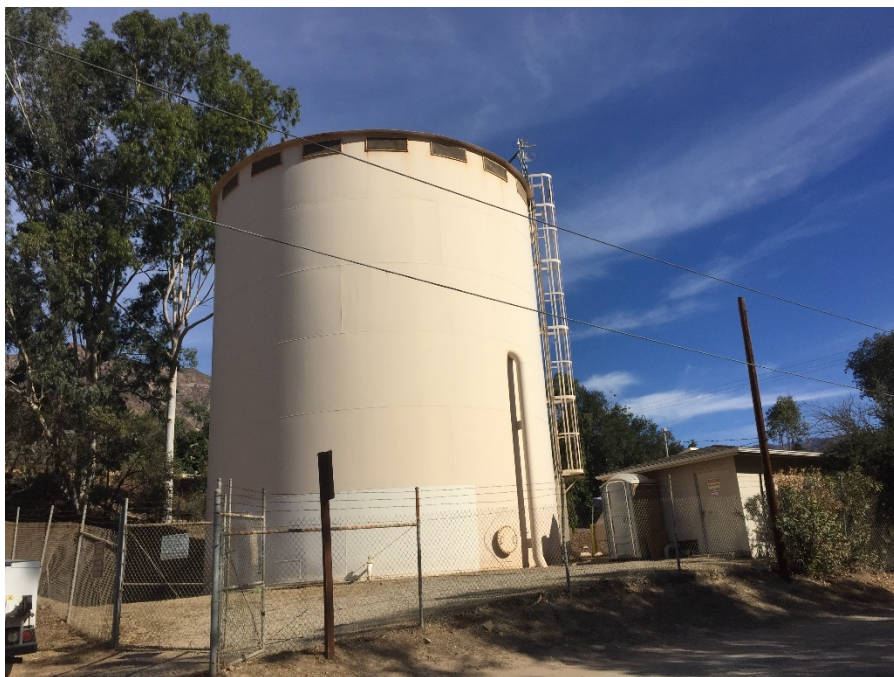
**Photograph 6.** View existing Arbolada tank within BSA, facing northeast (Unit B). Note ornamental vegetation surrounding the project footprint. November 13, 2018.
