## Board Meeting Agenda

### CASITAS MUNICIPAL WATER DISTRICT

# Robles Forebay Restoration Project

## Biological Resources Assessment

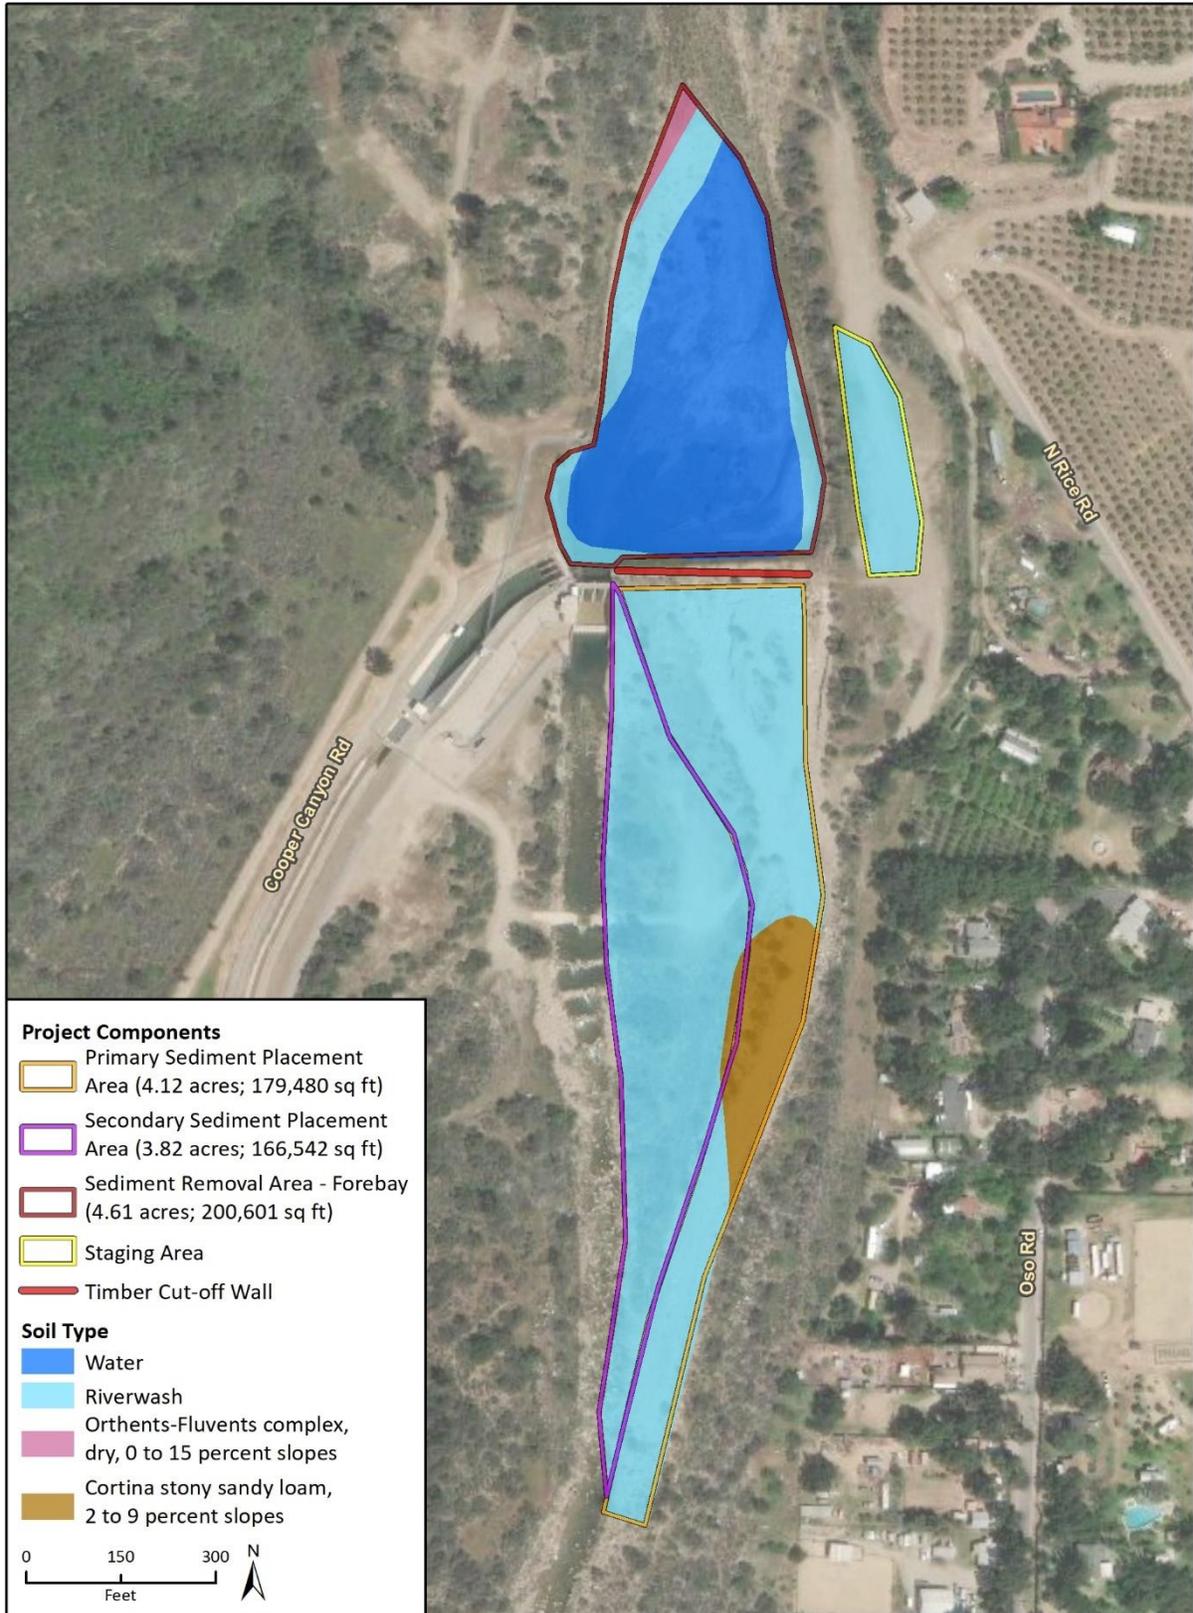
Fig. 3 Soils

**Figure 3 Soil Map**

Riverwash is designated as hydric soils in the Ventura Area (USDA, NRCS 2019).

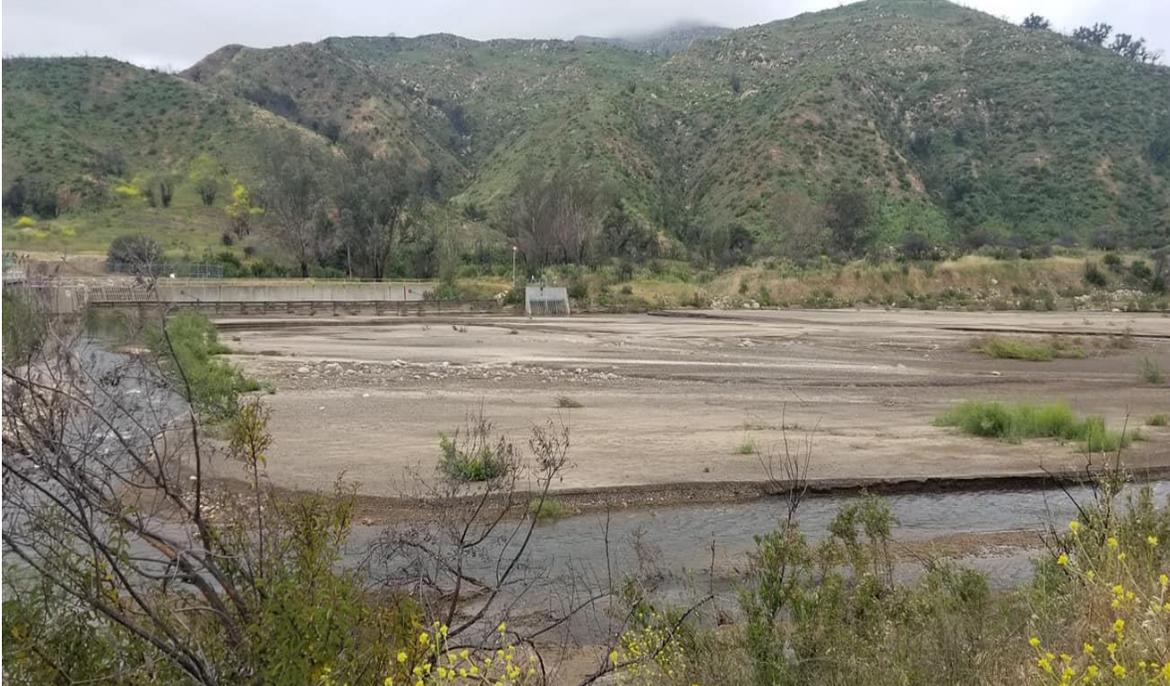
**Photograph 1** View of the forebay and accumulated sediment. Photograph was taken from the proposed staging area located east of the forebay, looking west toward the forebay and Robles Diversion Facility (April 16, 2019)

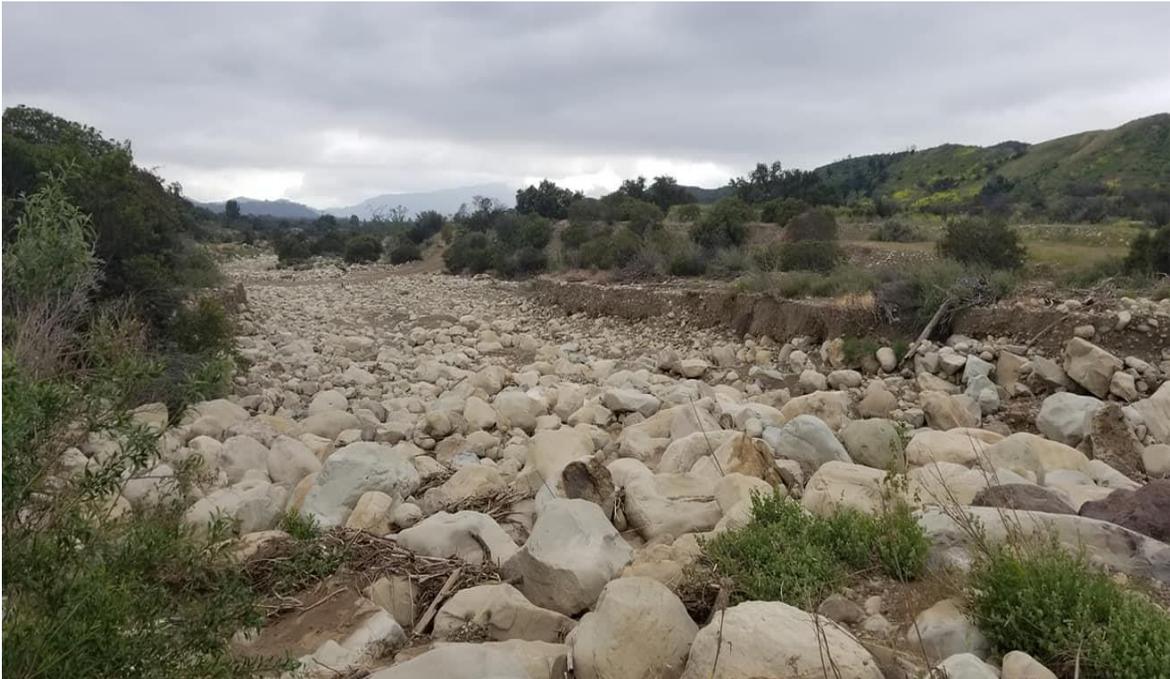
**Photograph 2** View looking downstream of the forebay area and timber cut-off wall. The Ventura River channel banks have sustained heavy erosion from storm events. Sediment removed from the forebay will be used to restore the channel banks (April 16, 2019).

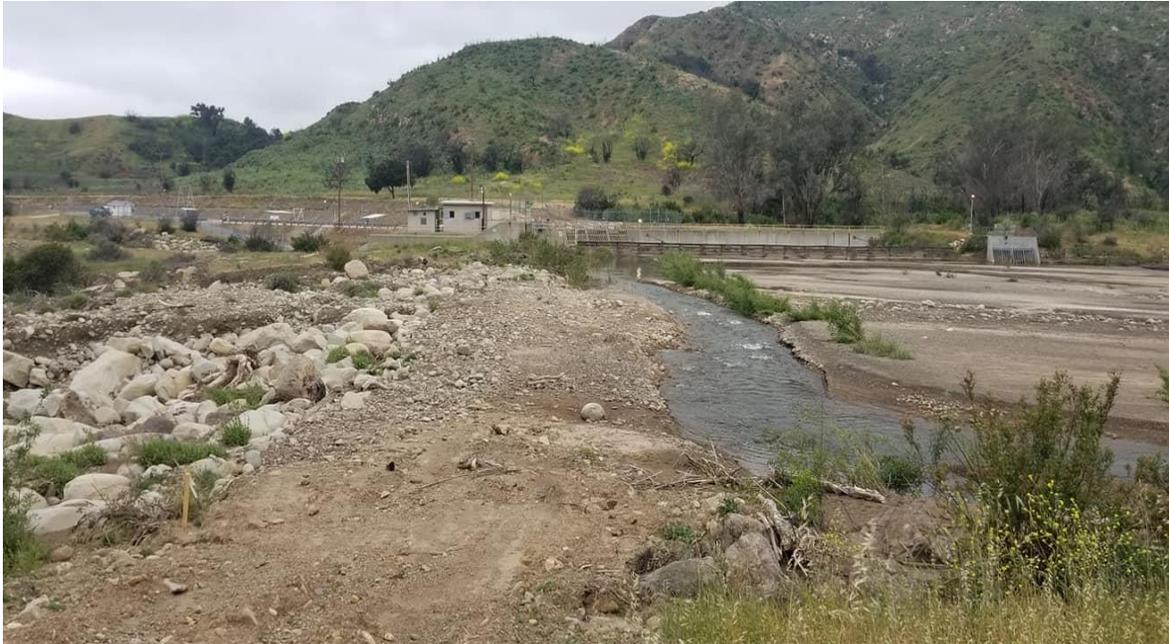
**Photograph 3** View standing on the east side of the timber cut-off wall, downstream of the forebay area, looking west toward the Facility. The Robles Facility cannot operate if the timber cutoff wall is breached because no forebay can be maintained. At this time, the volume of sediment in the forebay that was deposited during storm events will need to be removed to enable the Facility to operate as designed, both for water diversions and safe fish passage (April 16, 2019).

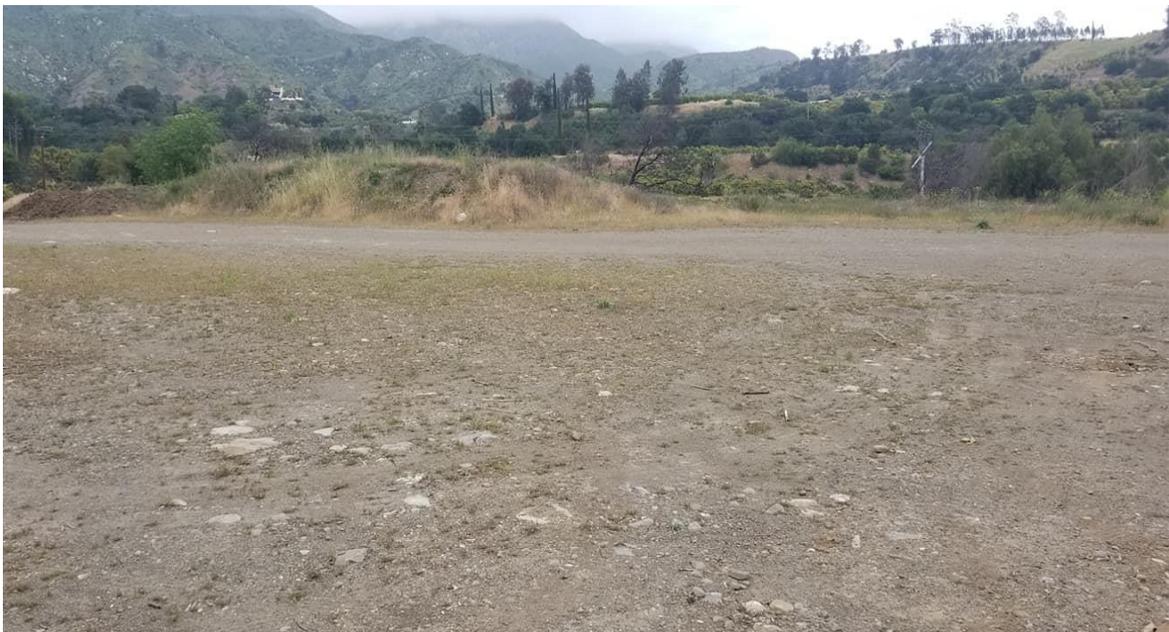
**Photograph 4** View of the disturbed area located east of the forebay. This area is proposed for staging of heavy equipment (April 16, 2019).

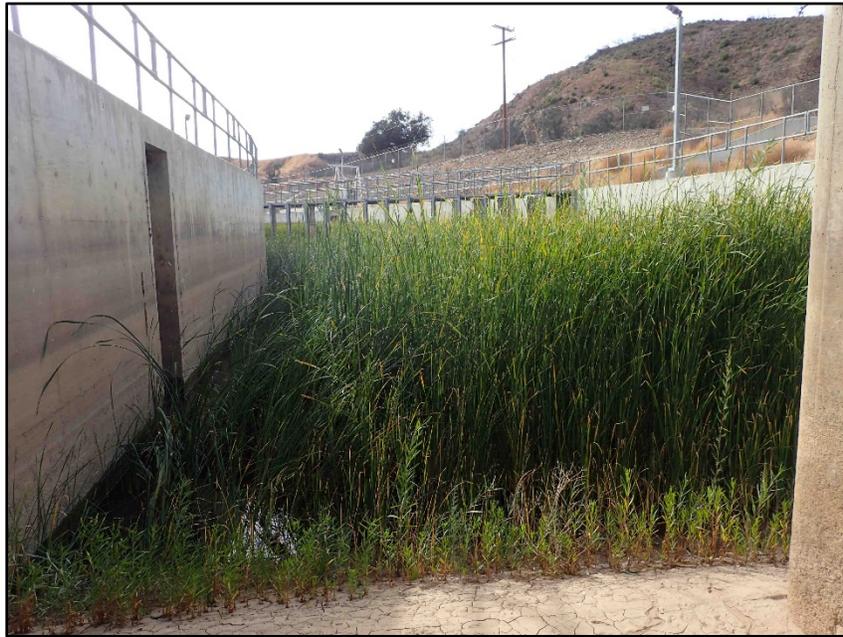
**Photo 11- Dense vegetation and sediment deposition in Robles Diversion screenbay**

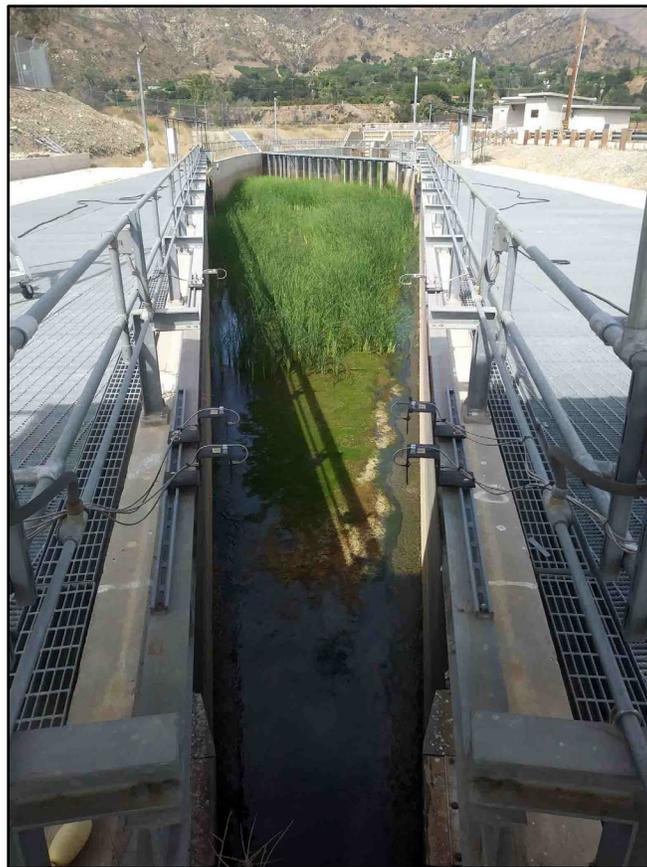
**Photo 12- Dense vegetation and sediment deposition in Robles Diversion screenbay**

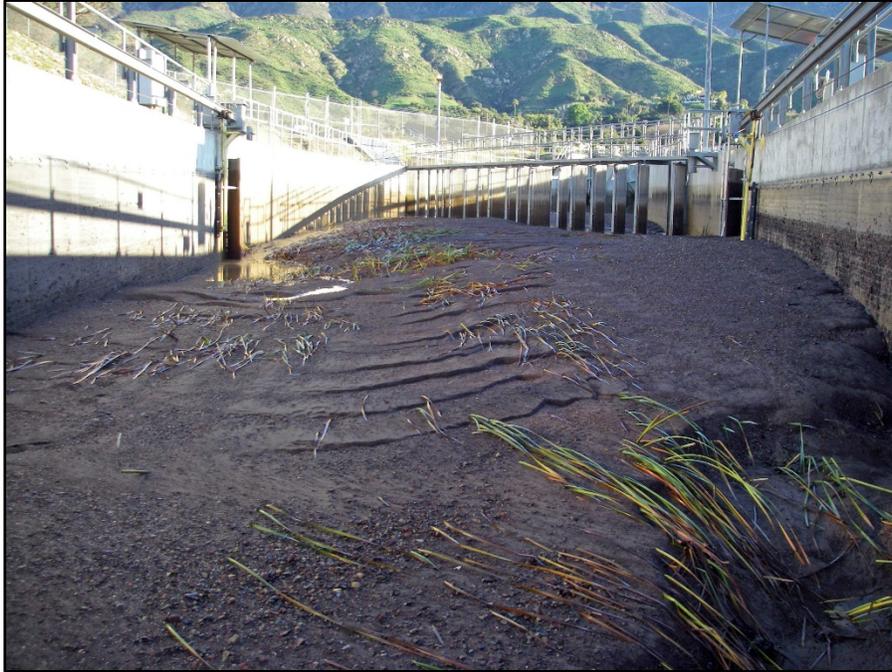
**Photo 13- Sediment inundation in Robles Diversion screenbay prior to emergency cleanout**

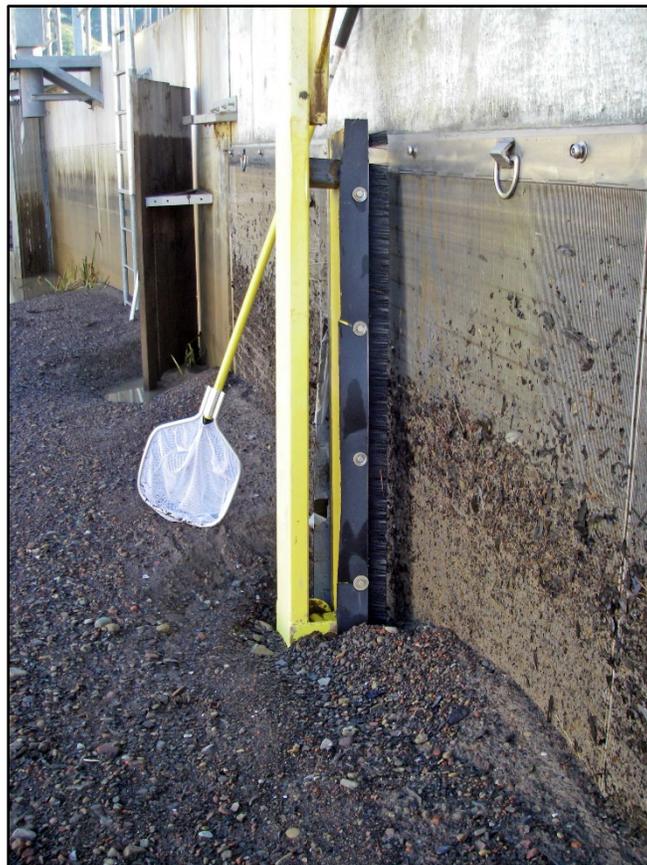
**Photo 14- Sediment inundating fish screens and brushes in Robles Diversion screenbay**
