Board Meeting Agenda

CASITAS MUNICIPAL WATER DISTRICT

Meeting to be held at the
Casitas Board Room
1055 Ventura Ave.
Oak View, CA 93022
April 24, 2019 @ 3:00 P.M.

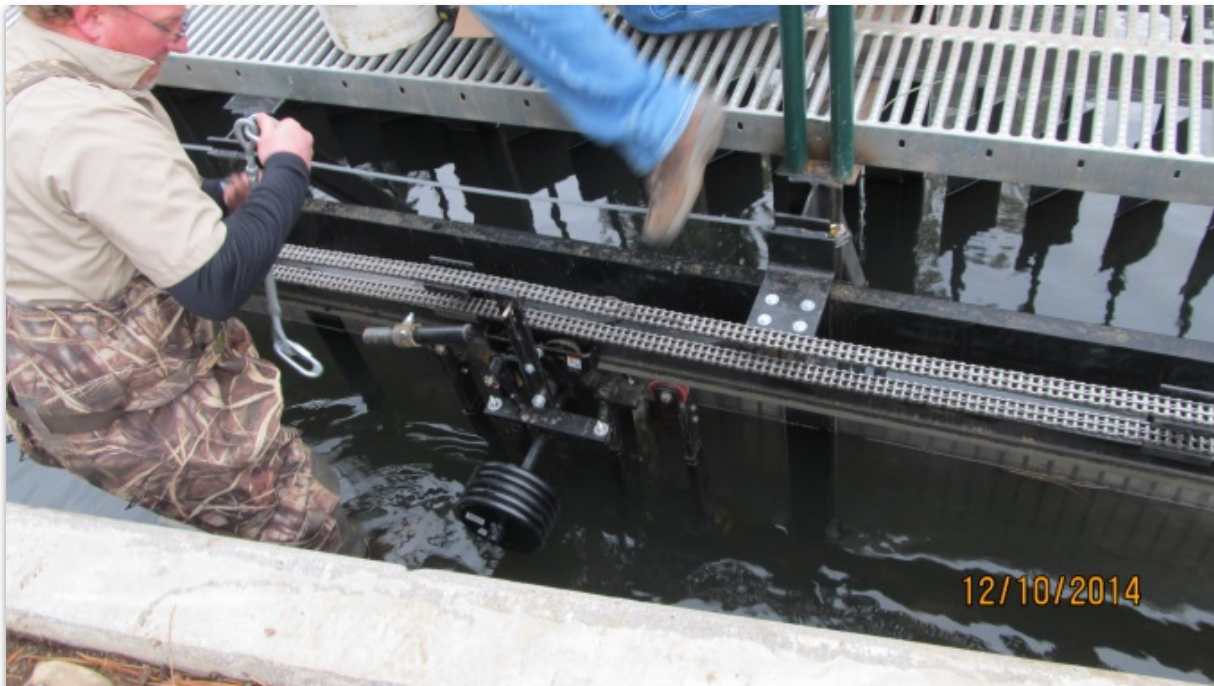
Figure 3-1: Chain Drive at the North Fork of the Sprague River, OR

If modifications to the existing drive system are not adequate to sufficiently address slipping and excessive wear of the sheave traction liners, the cable drive could be replaced with a chain drive system. An example of a fish screen with a chain drive is provided in Figure 3-1. Switching to a chain drive would require the existing sheave to be replaced with a sprocket. The teeth on the sprocket would prevent slipping. A shear pin or electrical overload protection would be needed to reduce the likelihood of damaging the sprocket or the motor. A chain drive is also compatible with other options to improve the performance of the existing system described below. Testing a chain drive system would require that a complete chain drive system be installed on one of the existing brush drives. A new drive/motor may be needed to handle the increased loads on the chain drive.

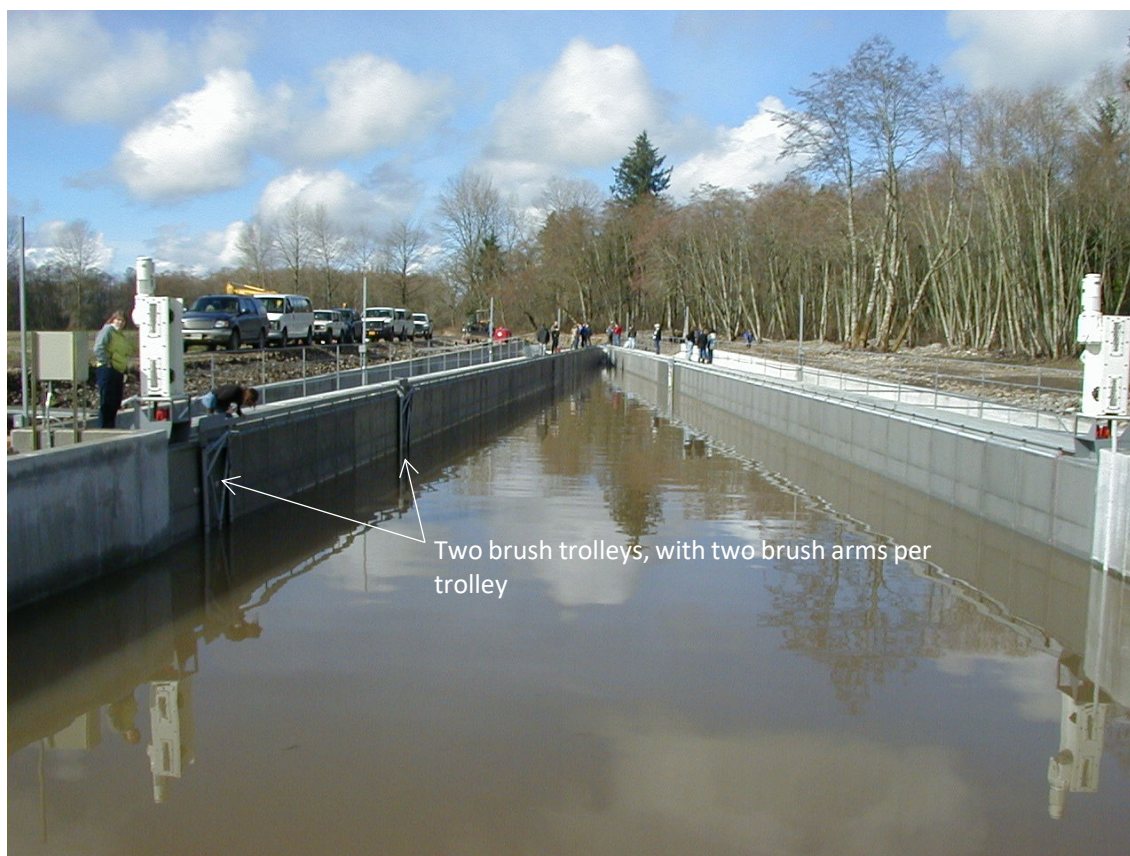
Figure 3-2: V-screen with Two Brush Systems per Side on the Santiam River, OR (Courtesy Santiam Water Control District)

A third option is to add a second brush arm to each cleaning system. This option would increase the frequency of cleaning while maintaining the same brush speed. A second brush arm on each side of the screen channel would be arranged so one brush cleans the upstream portion and the other brush cleans the downstream portion of the screen, as seen in Figure 3-2. This option essentially doubles the rate of cleaning, by cutting the cleaning length in half. Adding a second brush arm could be easily incorporated into the existing cable drive system by splicing in a second brush near the middle of the brush side of the cable. A new brush lifting mechanism would be needed at the center of the screen to allow debris to pass under the brush prior to switching directions. The second brush arm would increase the load on the motor and the tension on the cable and should be paired with a method to reduce wear and slippage of the sheave liner. This option could be paired with a modified brush arm, as described below, to provide overlap in cleaning zones. If prototype testing indicates that adding a second brush increases the cleaning rate of the screens, but overloads the motor or results in additional sheave liner slipping and wear, additional modifications such as replacing the existing motor with a larger motor, the use of a chain drive or the addition of a dedicated drive system for each brush could be considered.

A second potential brush modification is the addition of a twin brush arm to the existing trolleys, similar to the brush systems shown in Figure 3-2 and Figure 3-4. Spacing the brush arms several feet apart is advantageous over a single brush arm because the first arm removes the heavy debris while the second arm removes any remaining debris or debris that passes over the first brush arm. Each of the modified brush arms should have two brushes, a coarse outer brush and a fine inner brush. The existing brush and trolley could be modified to incorporate a second arm or a new trolley could be designed to better distribute the weight of the new brushes. In either case, a prototype brush can be added to the existing system with modest effort.

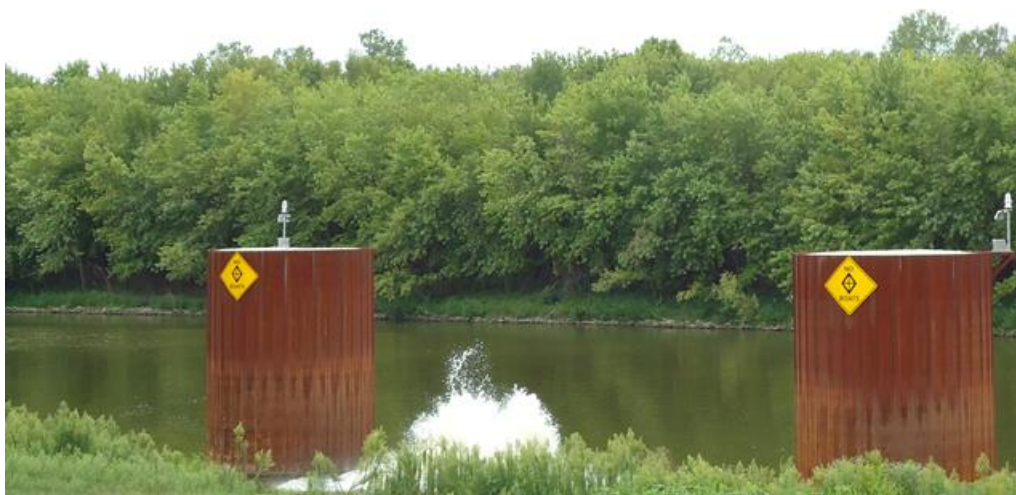
Figure 3-5: Surface Disturbance during an Air-burst

Backspray systems are typically designed as either air or water based systems. Air burst cleanings consist of a timed release of pressurized air to dislodge debris. This type of cleaning is typically used on cylindrical wedgewire wire screens where the burst of air expands and travels out and up through the wedgewire material, pushing debris away from the screen. For cylindrical wedgewire screens, approximately 2 to 3 screen volumes of air at an initial pressure of over 100 psig is used for cleaning. An example of the disturbance caused by an air burst on a cylindrical wedgewire screen is shown in Figure 3-5. Air burst systems have also been used with inclined flat plate screens, where the air moves debris up the screen as it expands. The Project Team is not aware of any air burst systems that are used with vertical flat panel screens. Adapting this type of system to a flat panel screen would require an air manifold system located at the bottom of each screen panel between the screen and the baffle plate. The air burst would operate sequentially starting at the upstream end of the screen and working downstream to reduce debris re-impingement onto recently cleaned panels. This type of air burst system is not designed for continuous cleaning. The cleaning frequency is a function of compressor power and receiver volume. A larger compressor and receiver would be required for more frequent cleaning. Continuous low pressure air has been used for debris and sediment management; however use of low pressure air systems is limited and does not have any advantages over the air sparging system identified in Alternative 1.

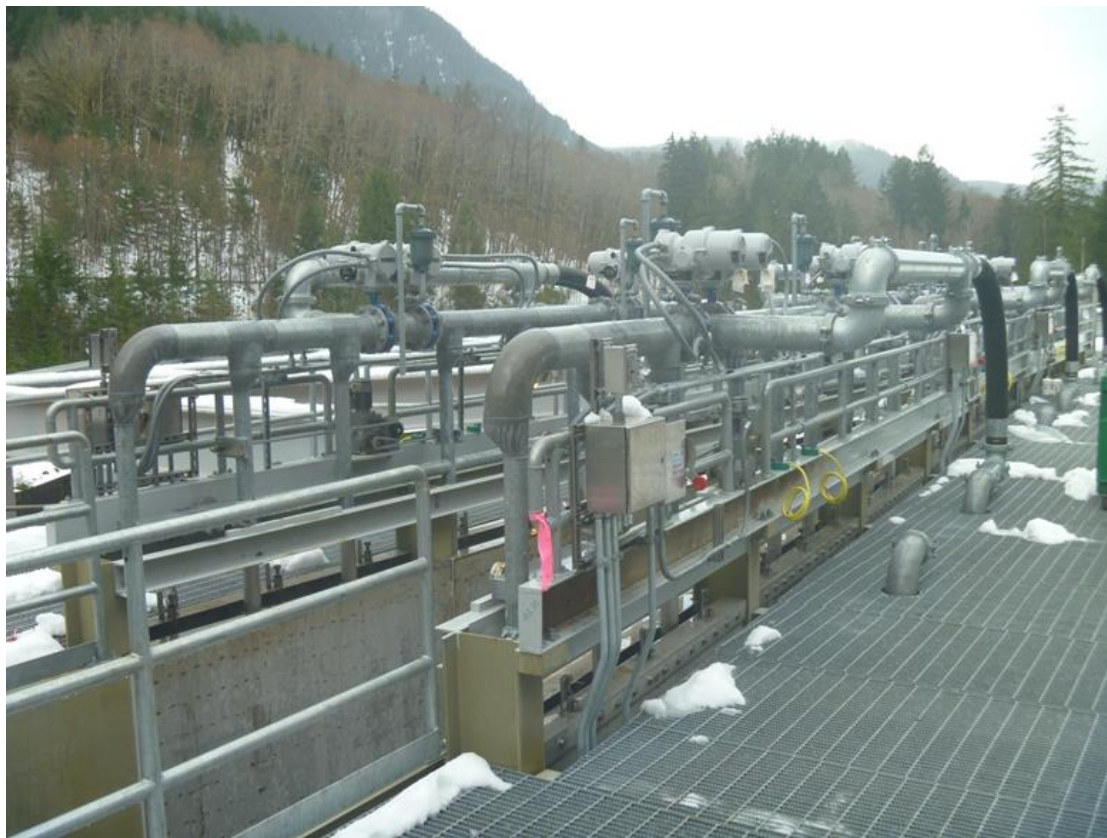
Figure 3-6: Flat Panel Screens with a Water Backspray at the Cowlitz Falls North Shore Collector on the Cowlitz River, Washington (Courtesy Tacoma Power)

Water pressure at the nozzles typically falls between 30 psig and 100 psig depending on the application. A water backspray was selected for Alternative 2.

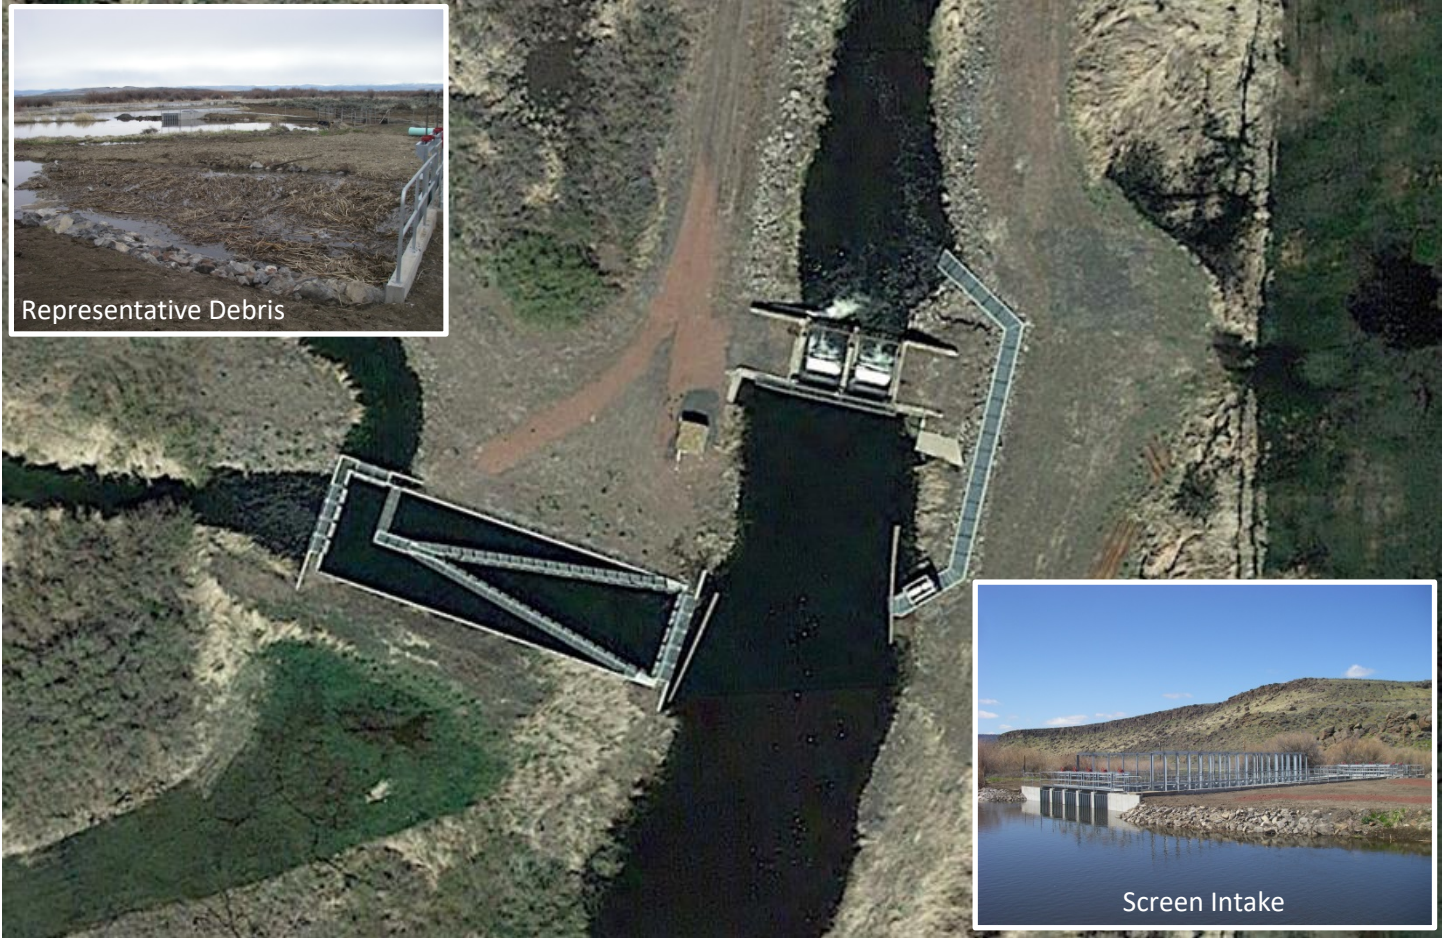
Project Name: A Canal

Relevance to Robles Diversion Alternatives: Brush-cleaned V-screen diversion channel. Chain drive. Includes upstream fish passage.

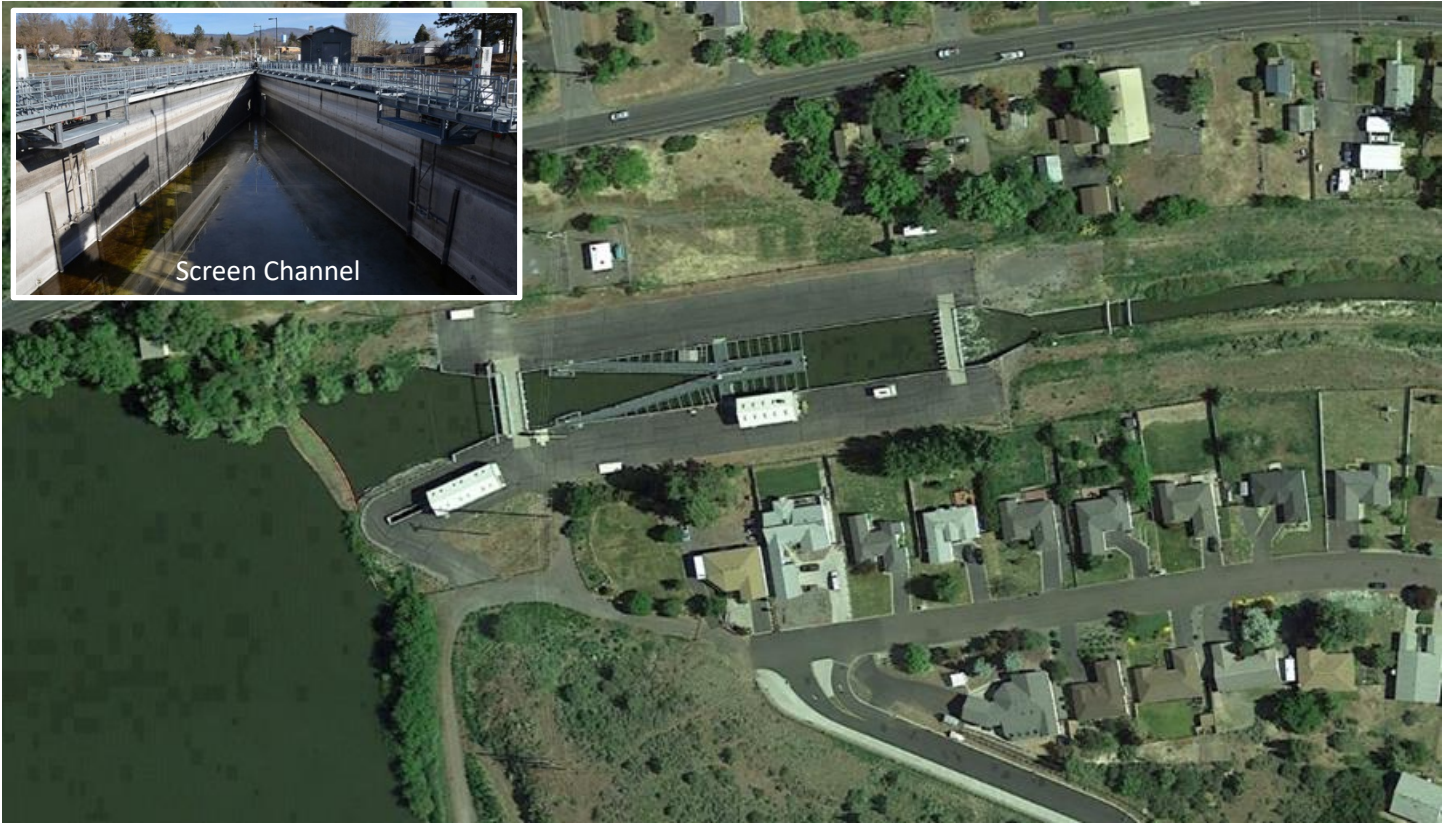
Project Name: Stayton Salem Diversion

Relevance to Robles Diversion Alternatives: V-screen diversion channel. Cable drive. Two brush arms per trolley. ESA-listed species.

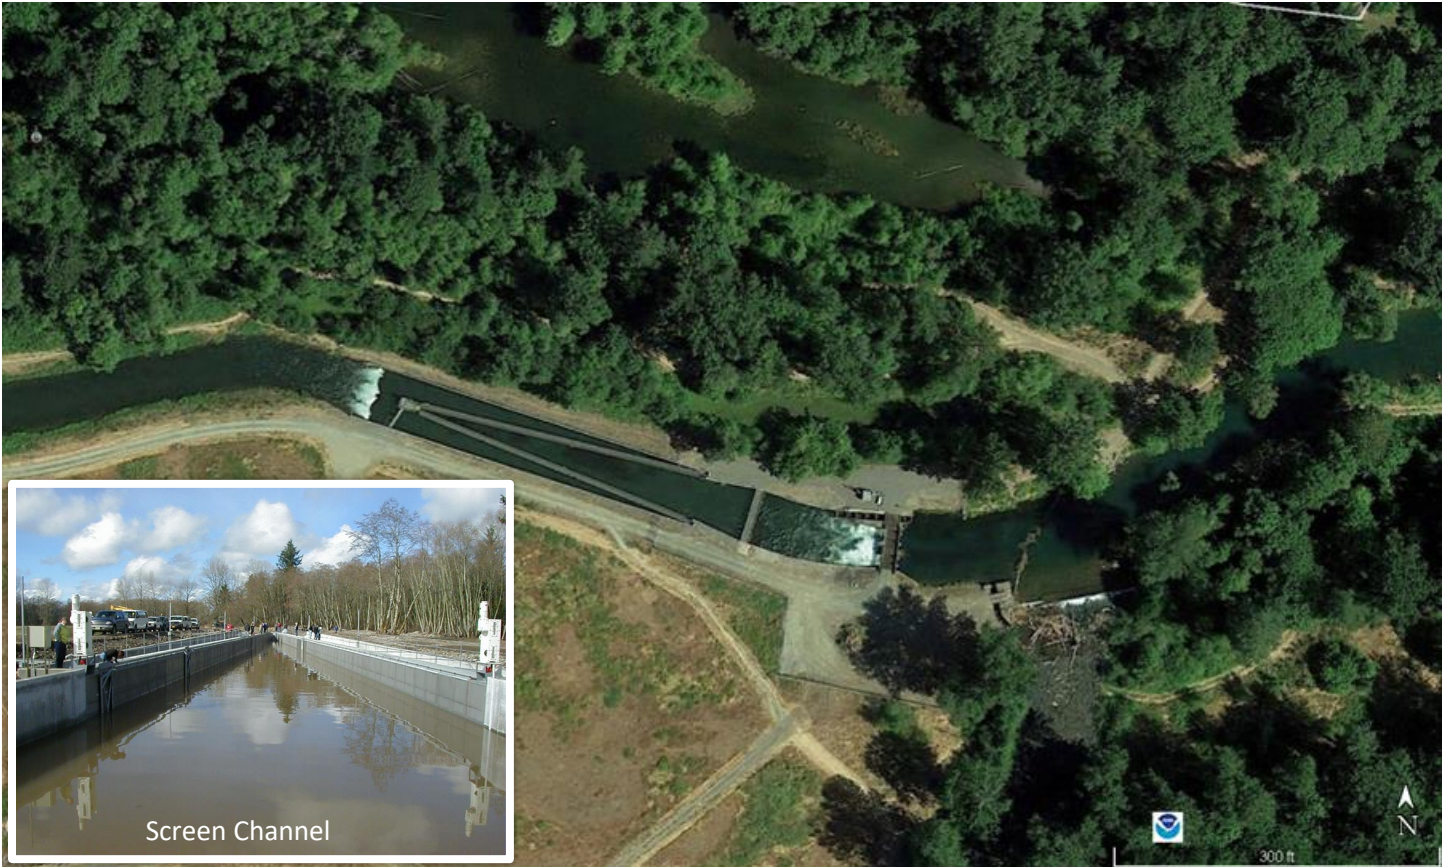
Project Name: Cowlitz Falls North Shore Fish Collector

Relevance to Robles Diversion Alternatives: V-screen diversion channel with perf plate, not wedgewire. Cable drive. Larger sheave diameter. Metal sheave. Two trolleys per side. Two brush arms per trolley. Salmon and steelhead (ESA listed)

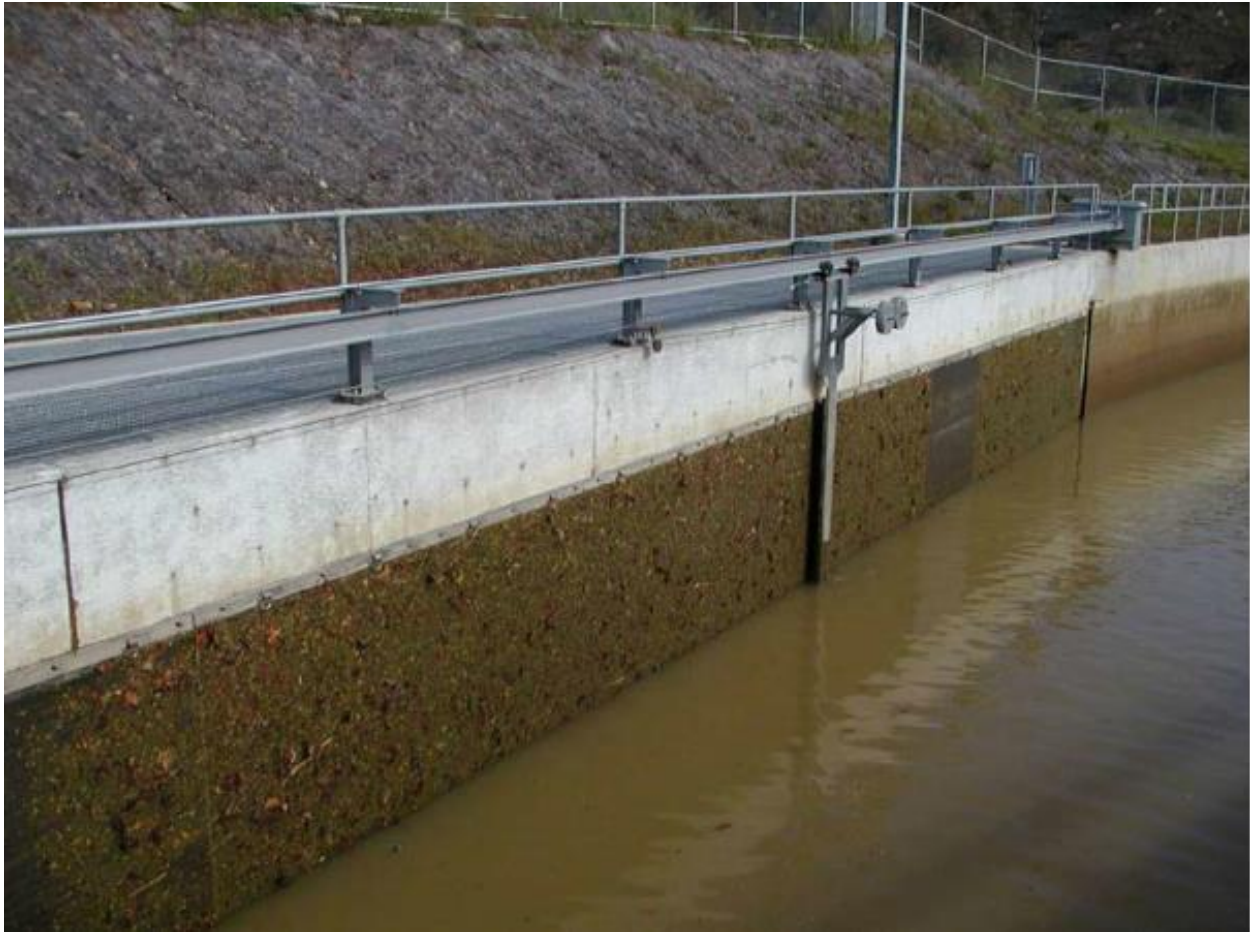
Photograph 1. View looking north of Robles Fish Passage Facility V-screens (west side of the Fish Screen Channel) of debris material that has accumulated on the screens.

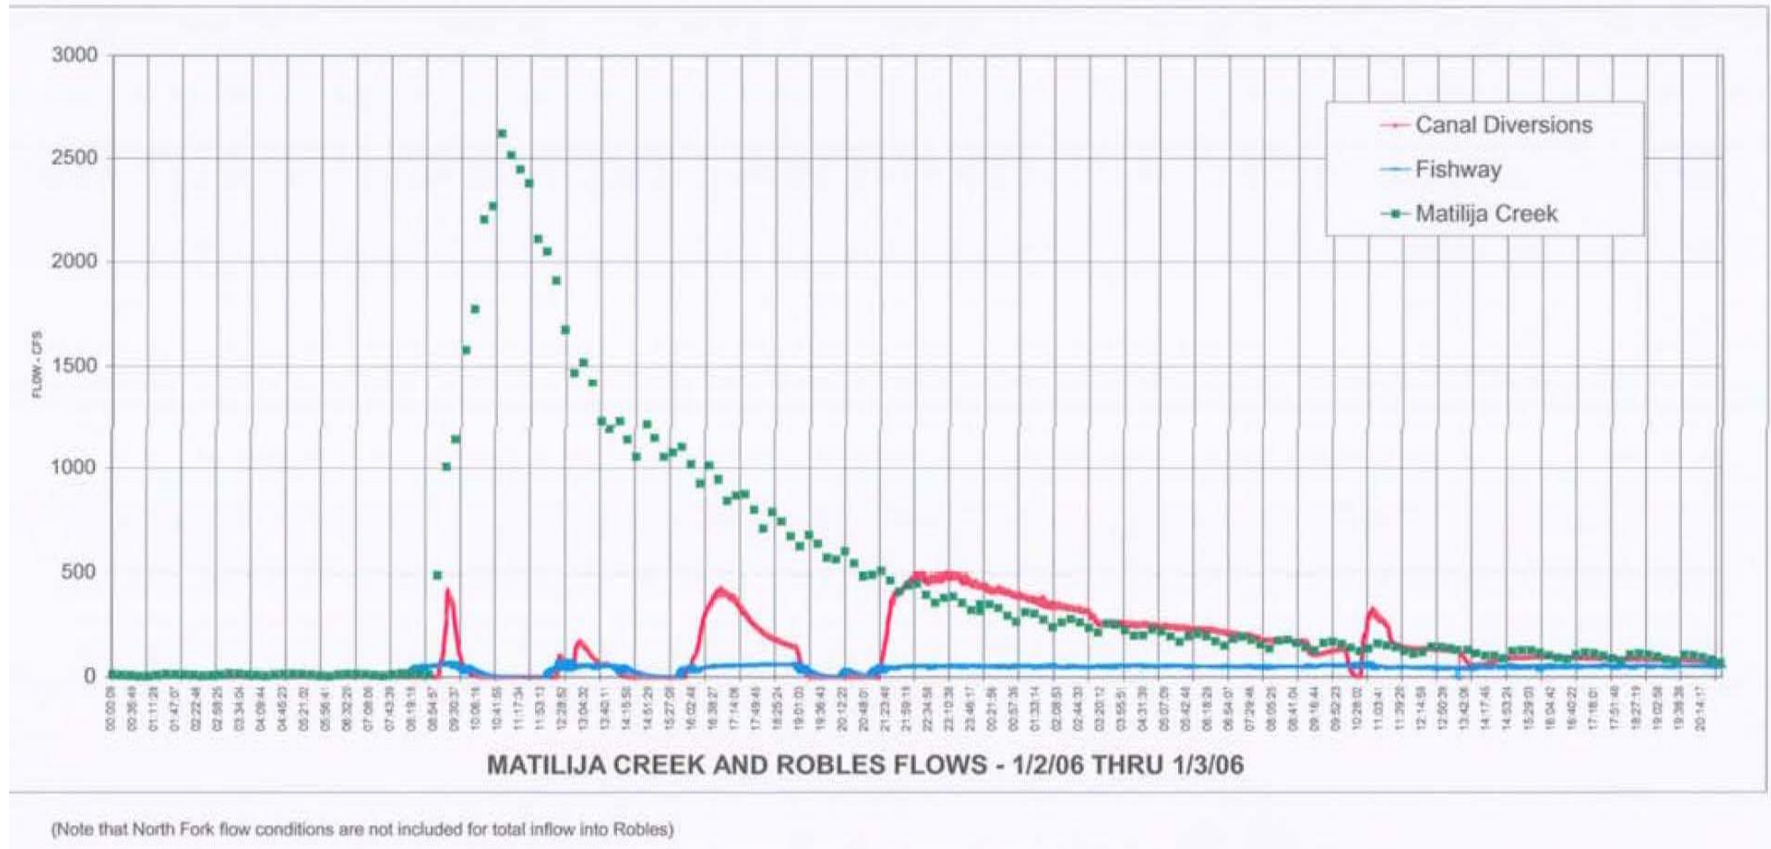
Figure 1. Storm Event of January 2 through 3, 2006

The screen cleaning system is unable to keep the screens clear during high flow conditions when there is substantial debris in the river. When debris clogs the fish screens the volume of flow that can be drawn through the screens and into the canal is reduced. In this scenario, CMWD can either withdraw water at a lower flow rate than the system is designed for, or CMWD staff can shut the system down to manually clean the screens and increase the withdrawal capacity. In both of these scenarios, the total volume of water diverted to Lake Casitas is less than the maximum possible. The figures below illustrate the gradual reduction in flow withdrawal as the screens become clogged, the periods in which the diversion is shut down to allow manual cleaning, and the subsequent increase in withdrawal rate through the clean screens.

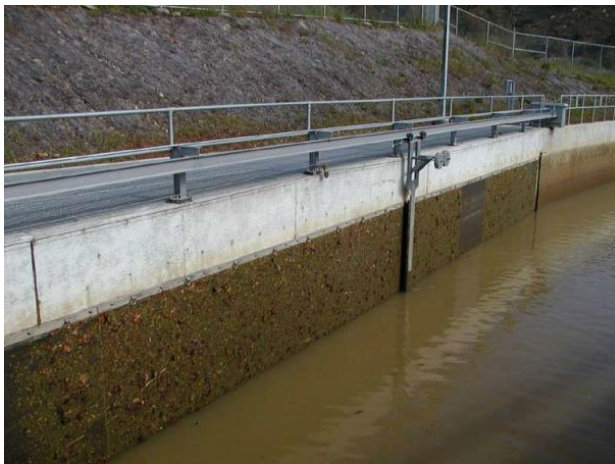
Figure 13. Typical Debris, Pre-Fire

It is not known whether the fire-related debris will be a long-term or a short-term phenomenon; however CMWD staff indicated that any screen cleaning improvements should consider both the standard vegetation debris and fire-related debris, because the possibility of future fires in the area cannot be dismissed.

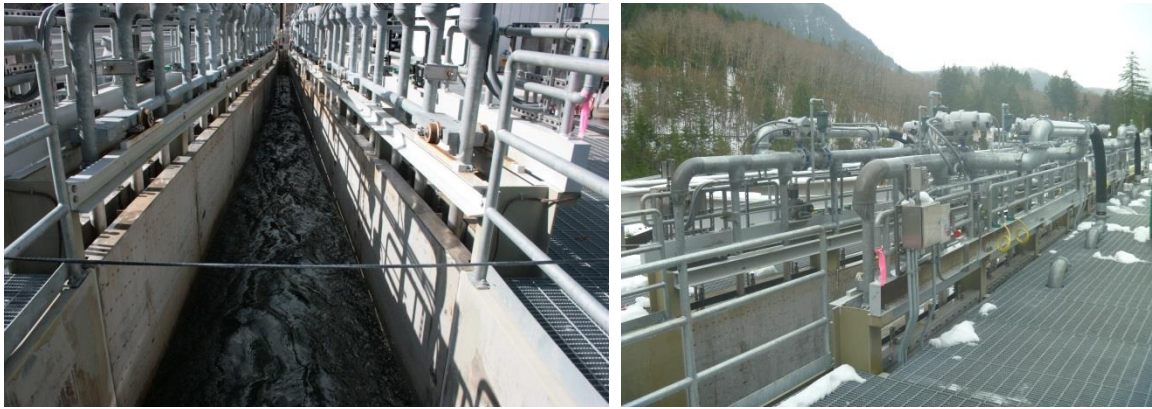
Figure 12. Backwash Carriage and Backwash System Piping (Cowlitz Fall Dam Fish Collection Facility)

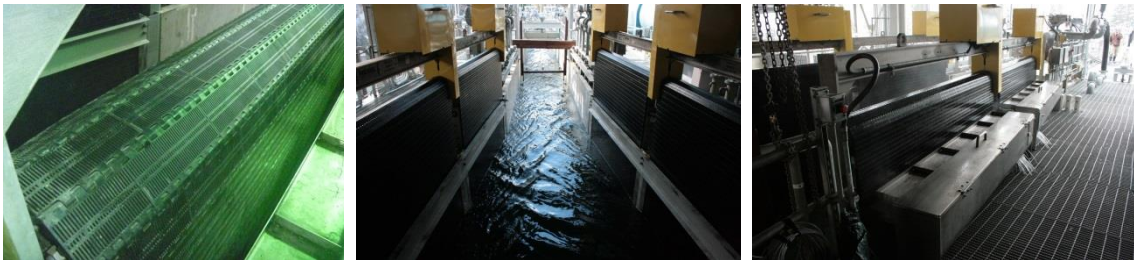
Figure 13. Traveling Screen System: a) Close Up, b) Upstream, c) Downstream (Cowlitz Falls Dam Fish Collection Facility)

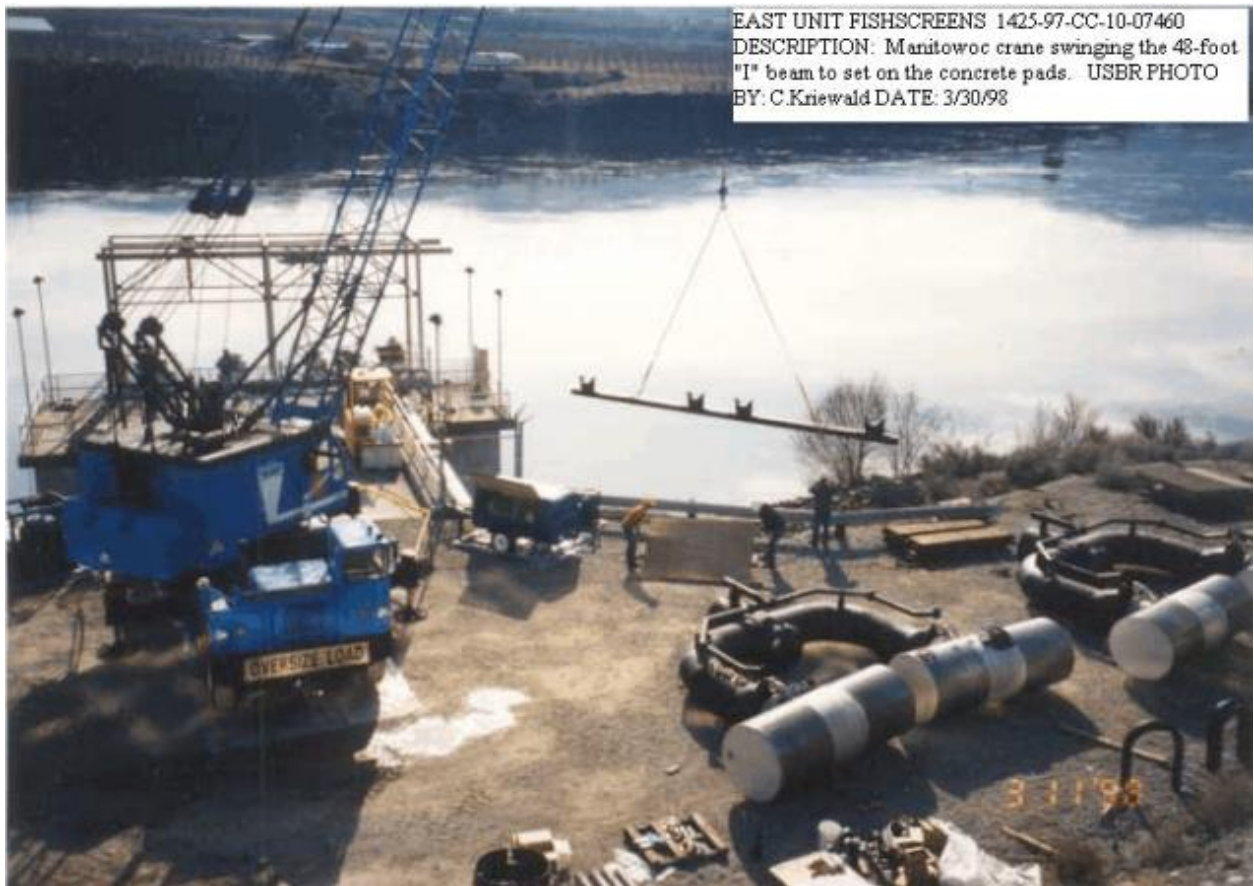
**Figure 16. Installation of Cylindrical Tee Screens, East Unit Pumping Plant, WA
(from USBR "Fish Protection at Water Diversions", 2006)**
